## Structural Evaluation

Alexander Crummell School  
1900 Gallaudet Street, NE  
Washington, D.C.

*April 29, 2008*

Provided By:  
**Faithful+Gould, Inc.**

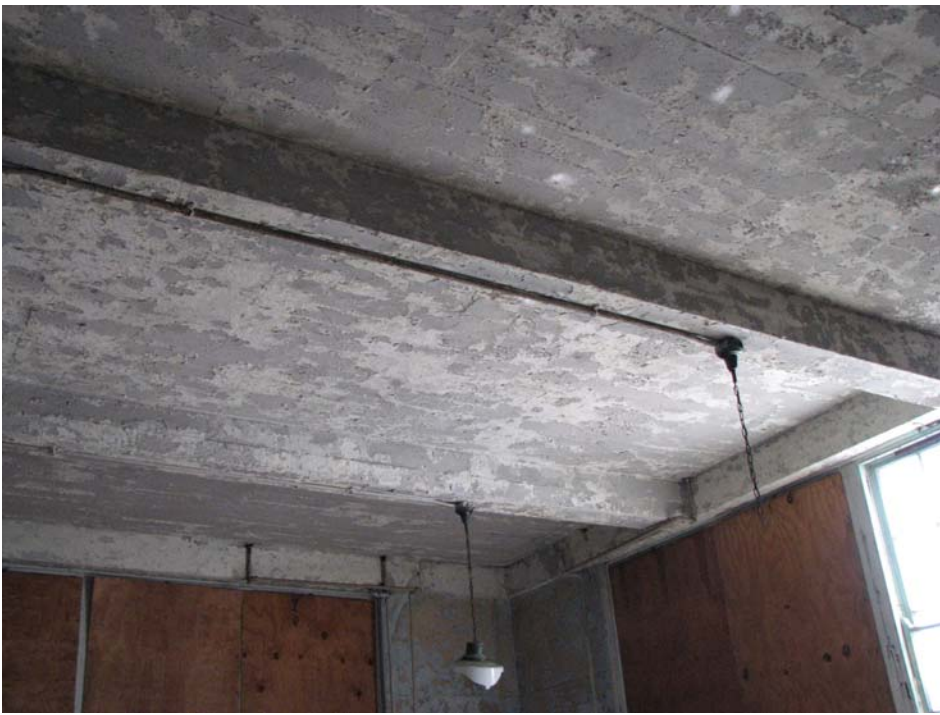
Photograph Number 1

Overview of elevated concrete floor system showing flat panel system supported on concrete encased steel joists. System is in generally good condition

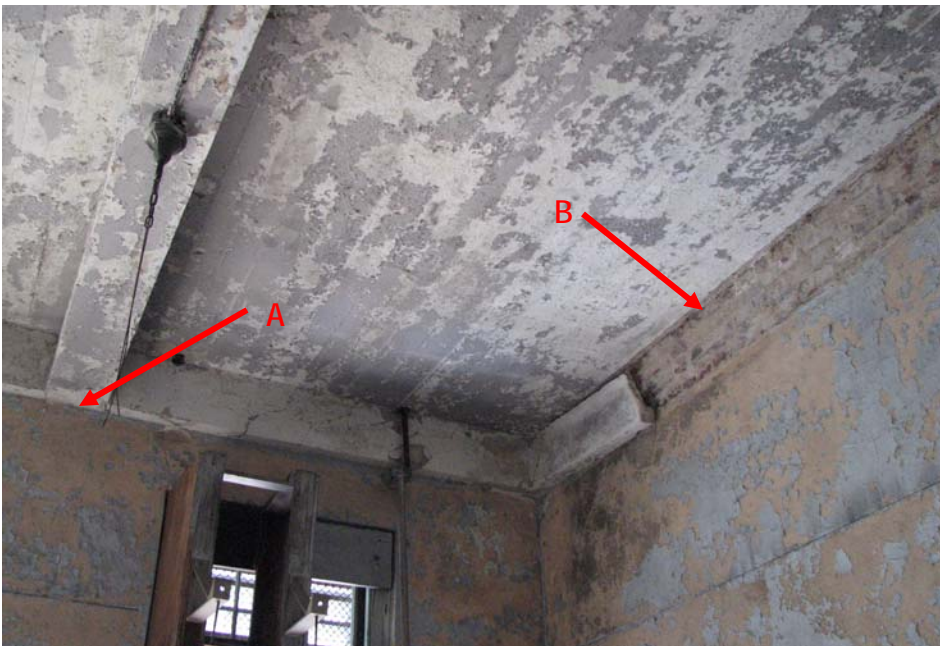
Photograph Number 2

Flat panel elevated floor system showing concrete encased steel joist bearing onto perimeter load-bearing brick wall (A). Note also support provided by interior load-bearing brick wall (B).

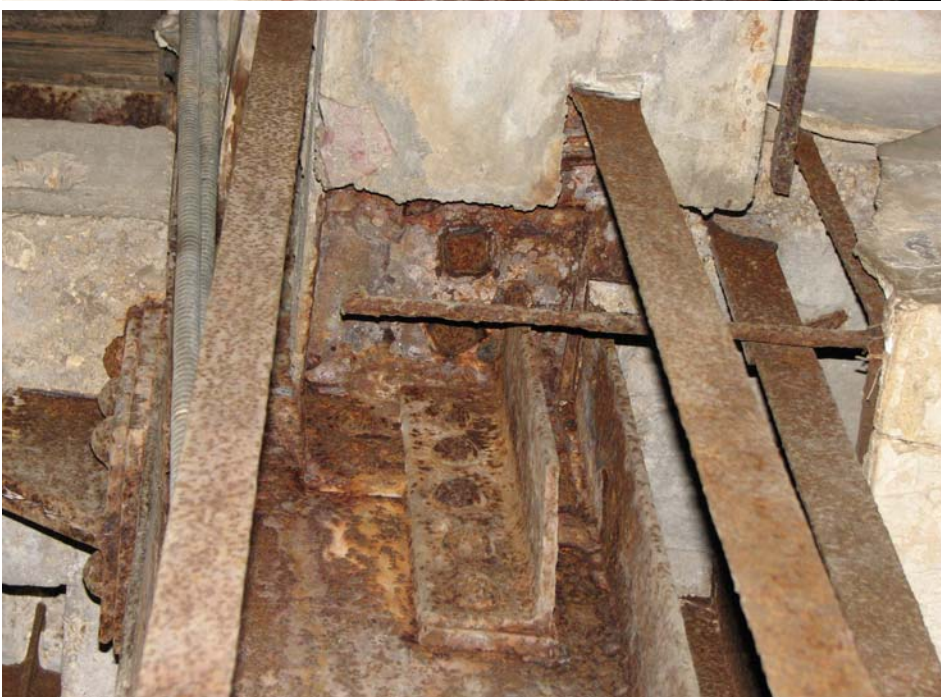
Photograph Number 6

Bolted connection between steel column and girder at central core. Note corrosion appears surface in nature and should not affect the capacity of the system

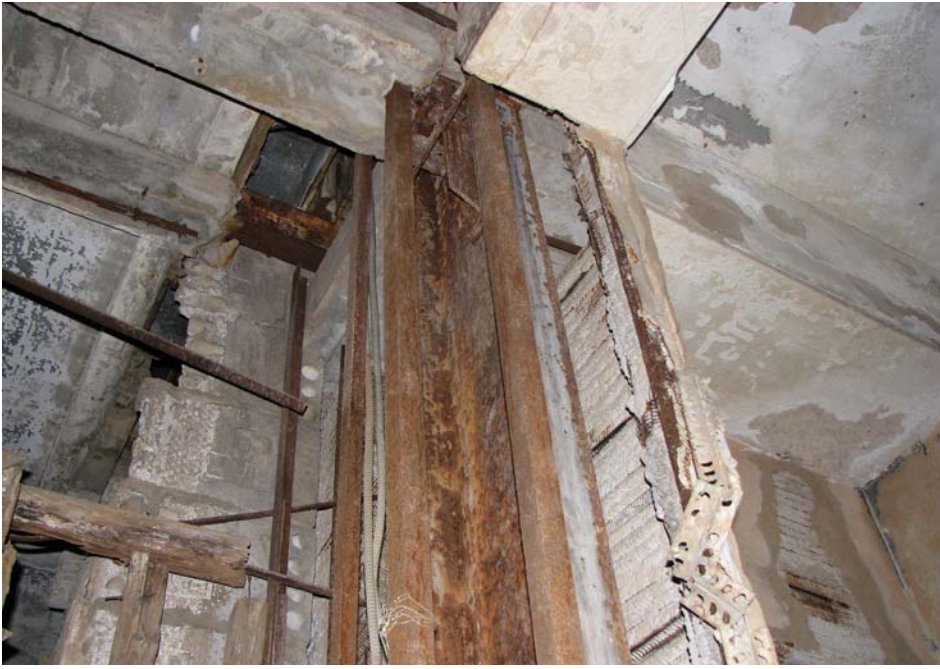
Photograph Number 7

Typical column at central core in good condition

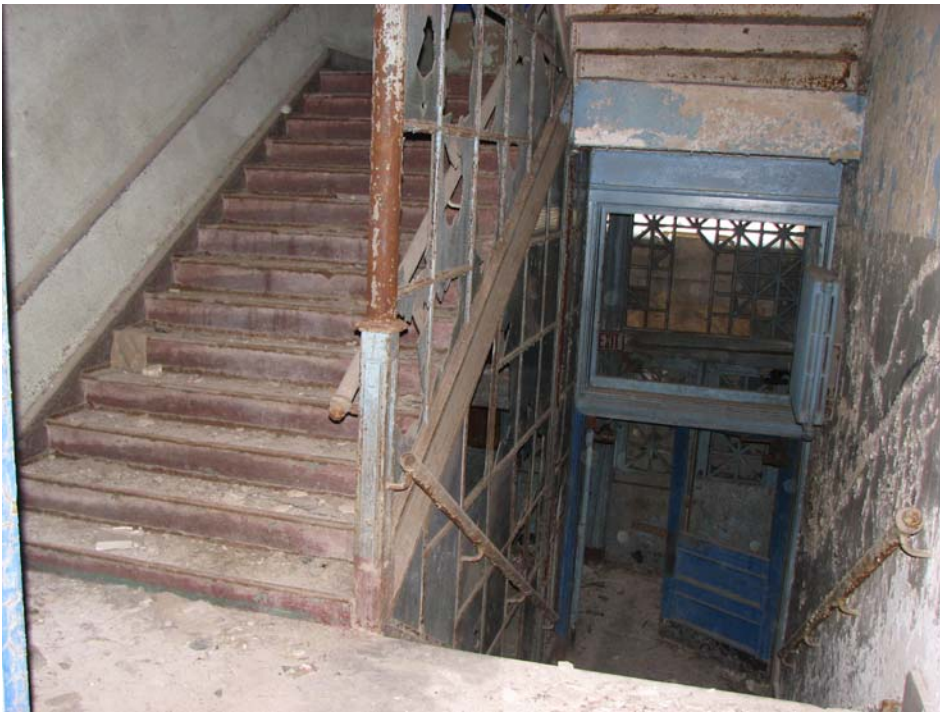
Photograph Number 11

Prior to 2003, the original roof system was severely deteriorated, resulting in extensive and prolonged water ingress into the building. This ingress resulted in significant deterioration and general failure of the two stair assemblies. We noted numerous instances of sectional corrosion at treads and at the tread to riser connection, and complete detachment and failure of numerous steps sections (reference Photographs 25 & 26 in Appendix B). We have recommended budgeting for complete replacement of the stairs prior to continued access or occupancy.

Underside of typical stair section. Note areas of surface and sectional corrosion

1. We recommend that the deteriorated stair systems be replaced. Our opinion of cost to replace the stairs is \$75,900 (\$115 per square foot) in 2008. This opinion of cost includes a allowance of \$15,000 for the retention of a District of Columbia registered structural engineer to design and specify the replacement system, and assumes for removal of the existing stair and railing assemblies, retention of the intermediate landings, and the installation of code compliant high quality commercial grade steel pan stair assemblies with cast-in-place concrete treads.
2. Although in presently acceptable condition, we recommend that funds be allocated for tuckpointing of the exterior wall system. Our opinion of cost to tuckpoint approximately 10% of the exterior wall system is \$20,500 (\$25 per square foot) in 2012.

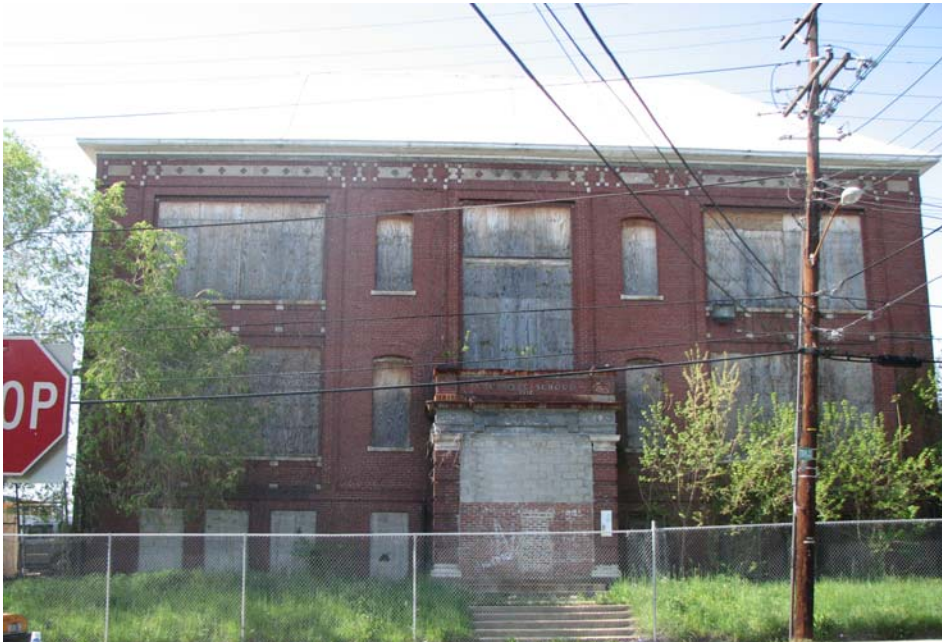
Photograph Number 13

Front (south) elevation of building as seen from Gallaudet Street. The exterior wall system is in generally good structural condition

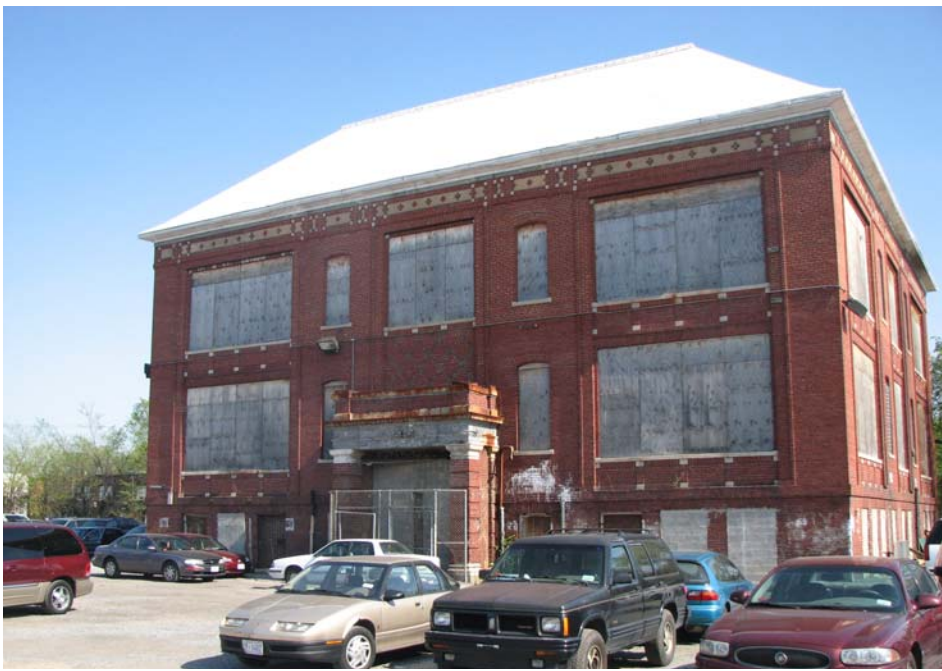
Photograph Number 14

Rear (north) elevation as seen from District of Columbia Public Schools parking lot. The exterior wall system is in generally good structural condition

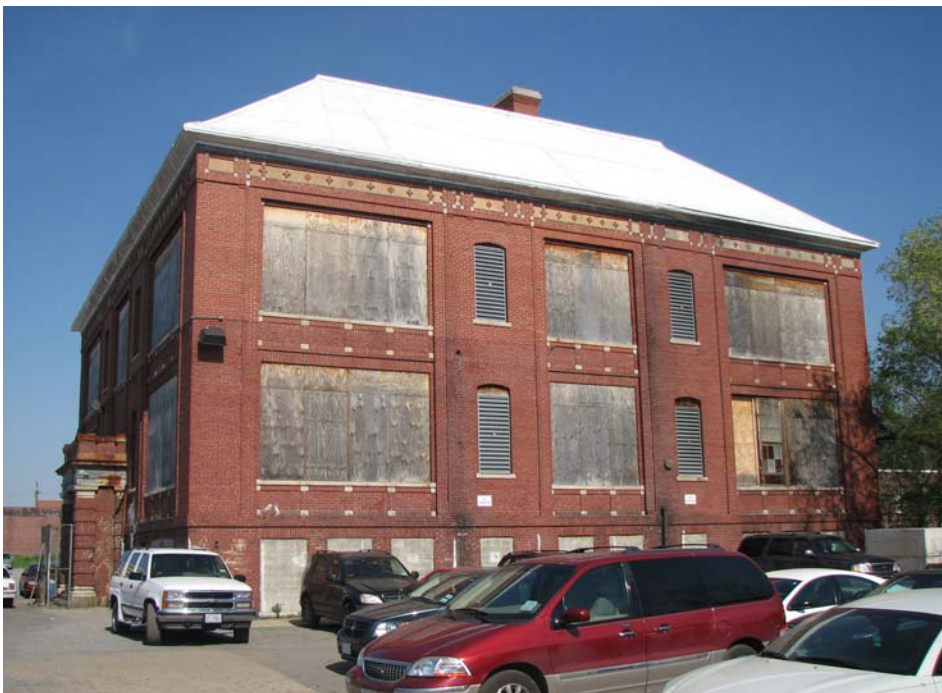
Photograph Number 15

West elevation as seen from District of Columbia Public Schools parking lot. The exterior wall system is in generally good structural condition

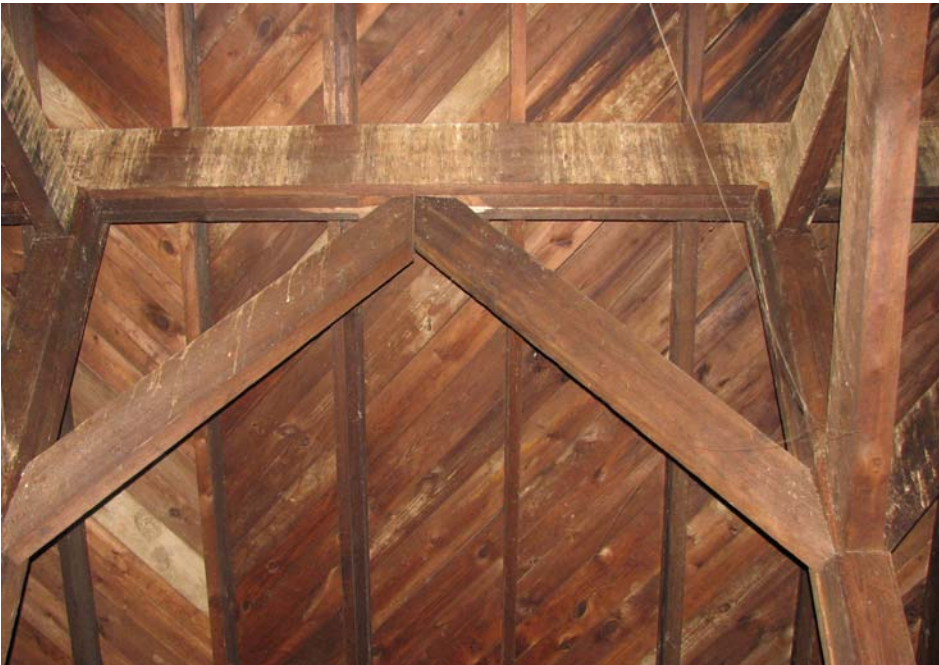
Photograph Number 18

Original and replacement roof areas as seen from second floor. Roof system is in generally good condition

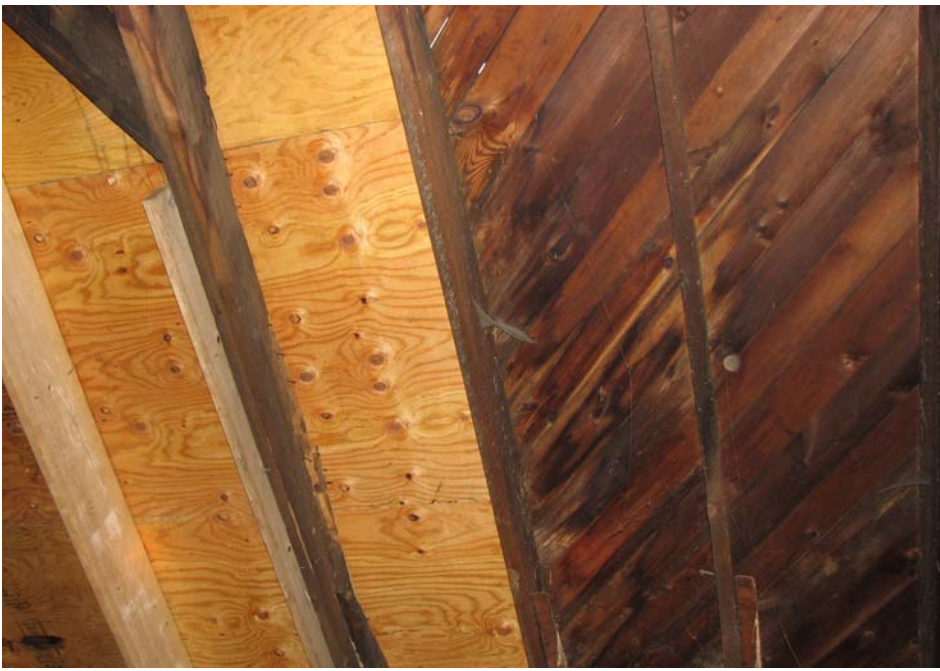
Photograph Number 19

Original and replacement roof decking systems in good condition

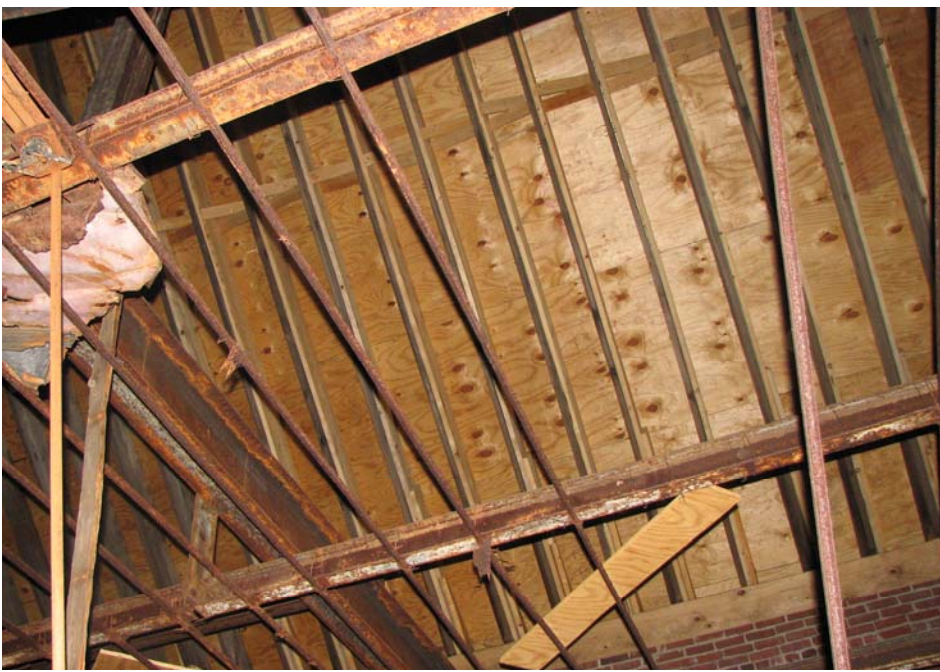
Photograph Number 20

Replacement roof decking (sheathing) in good condition. Note sistered roof joists

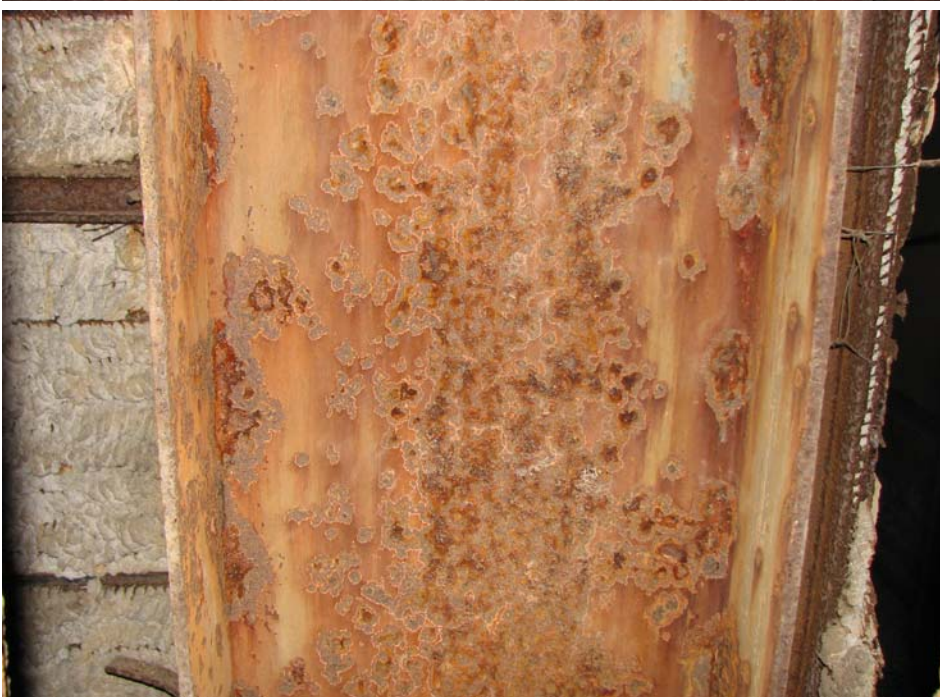
Photograph Number 24

The steel-framed superstructure appeared to be in good condition. We noted only localized instances of surface corrosion (reference Photograph 24 in Appendix B), and no significant instances of structural deflection, sectional corrosion, flange corrosion, deterioration of fasteners or other areas of deterioration that would reduce the systems integrity or life-cycle.

Surface corrosion at steel column

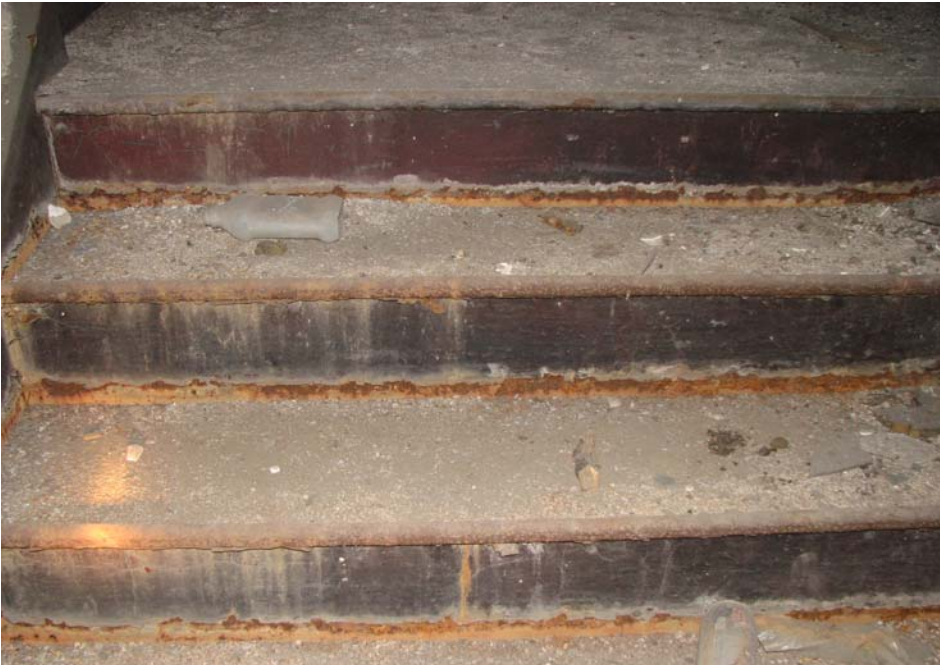
Photograph Number 25

Sectional corrosion at tread to riser connection at stairs. Stairs should be replaced near-term

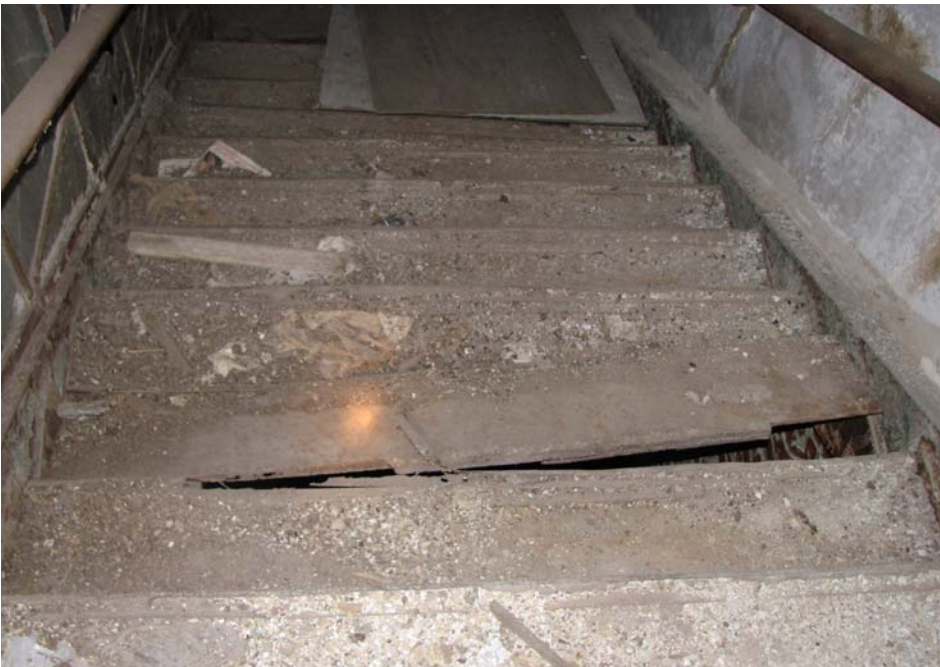
Photograph Number 26

Structural failure at stairs. Stairs should be replaced near-term

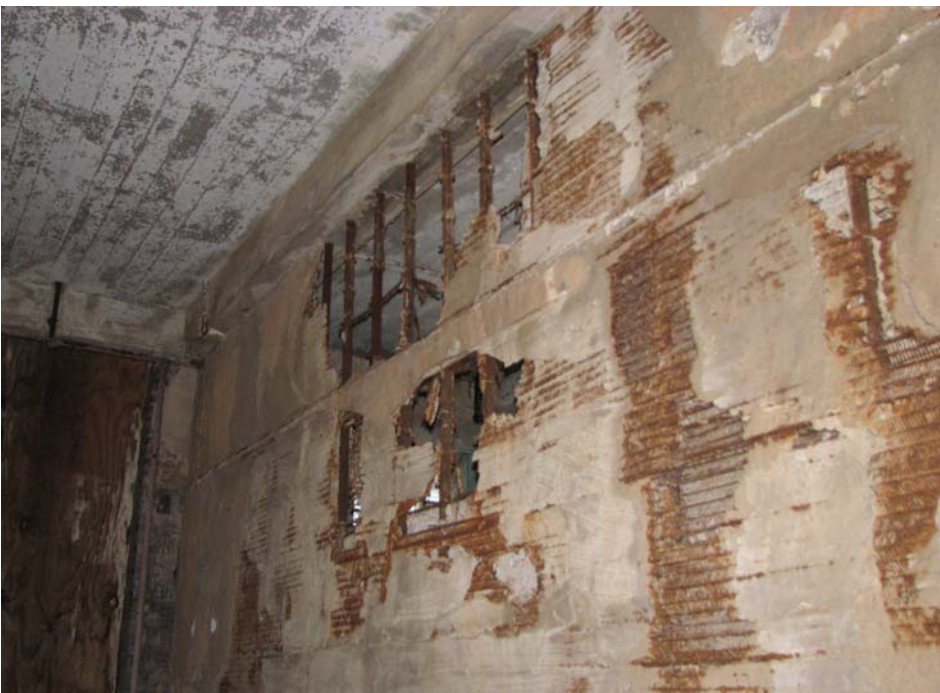
Photograph Number 27

Interior non-load bearing walls were in generally poor condition with widespread instances of stud and mesh corrosion, and impact damage noted (reference Photograph 27 in Appendix B). Replacement will be required prior re-use. As a non-structural element, we have assumed that replacement of non structural walls will be completed as part of any re-configuration of the interiors, and have therefore not included costs for this work within the attached capital expenditure forecast.

Widespread corrosion and failure of steel studs, steel mesh and plaster cover at non load-bearing partition wall system

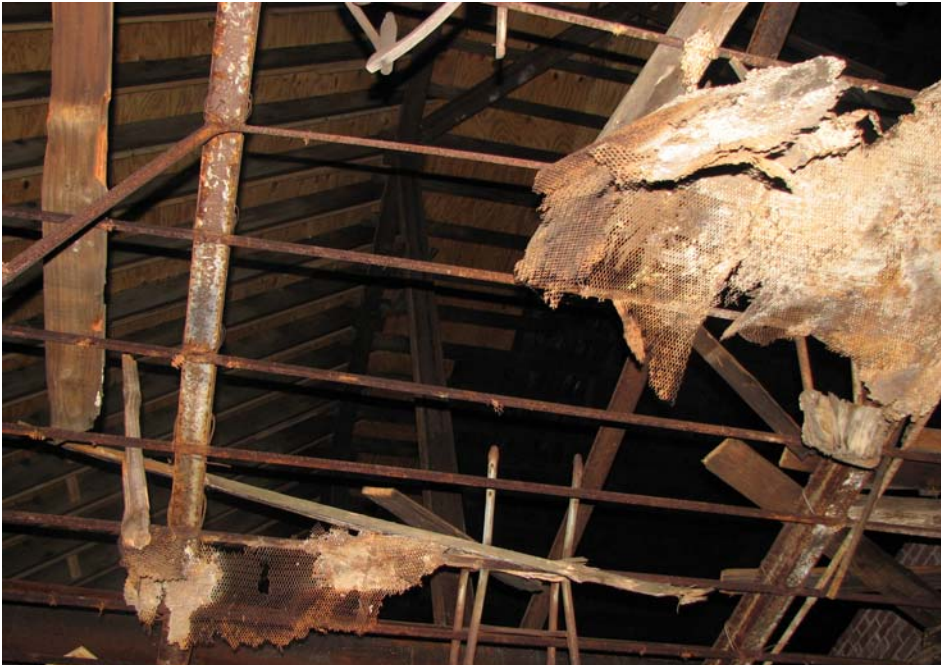
Photograph Number 28

Non-load bearing ceiling systems were in generally poor condition with widespread instances of steel and mesh corrosion, and historic water damage noted (reference Photographs 28 through 30 in Appendix B). Replacement will be required prior re-use. As a non-structural element, we have assumed that replacement of non structural ceiling systems will be completed as part of any refurbishment of the interiors, and have therefore not included costs for this work within the attached capital expenditure forecast.

Failure of steel ceiling system above second floor

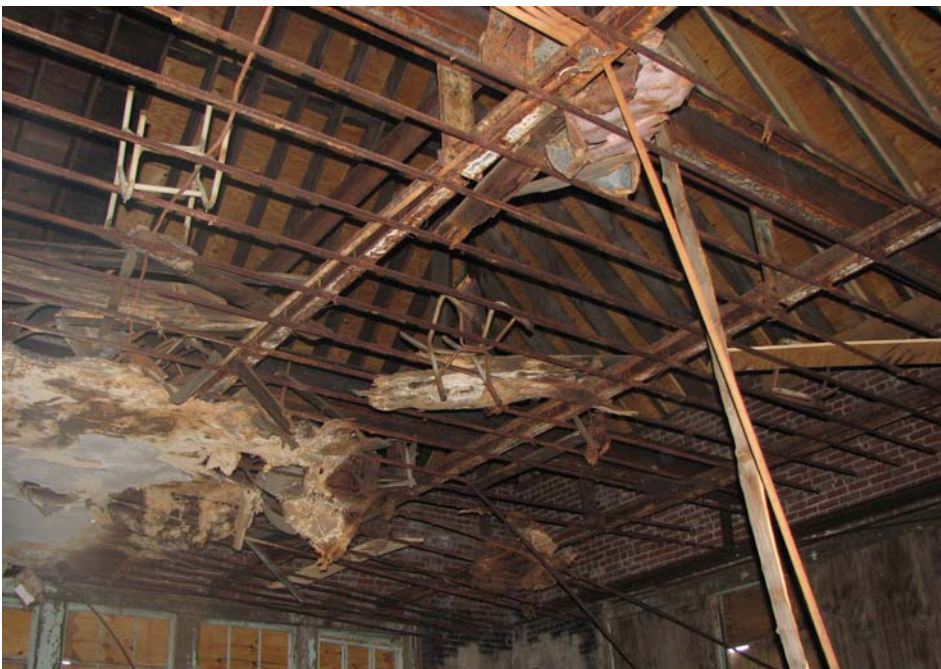
Photograph Number 29

Failure of steel ceiling system above second floor

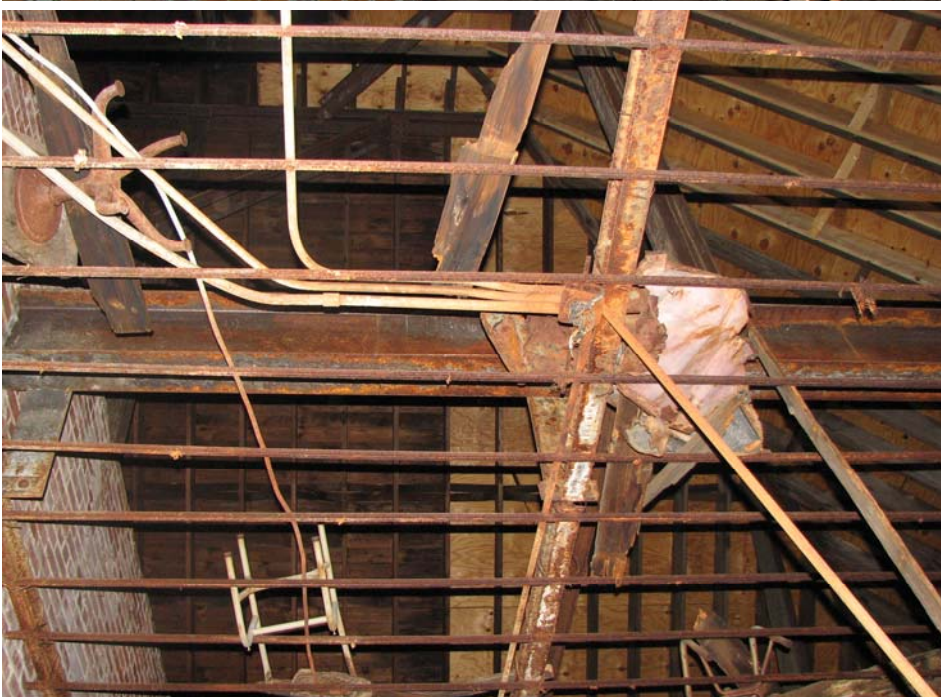
Photograph Number 30

Failure of steel ceiling system above second floor
