DMPED PARKING DECK STRUCTURAL INVESTIGATION

Prepared by: **McMullan & Associates, Inc.**
M&A Project No. 3767

DRAFT SUBMISSION
SEPTEMBER 2, 2016

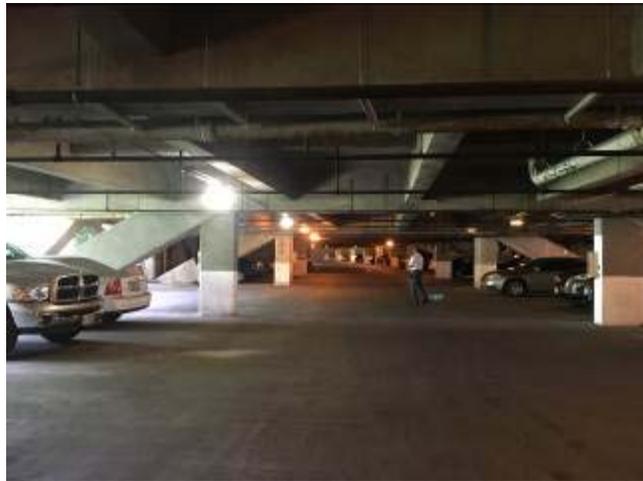
1. Overall view of the garage supported on the lower slab. Steel truss configuration can be seen.

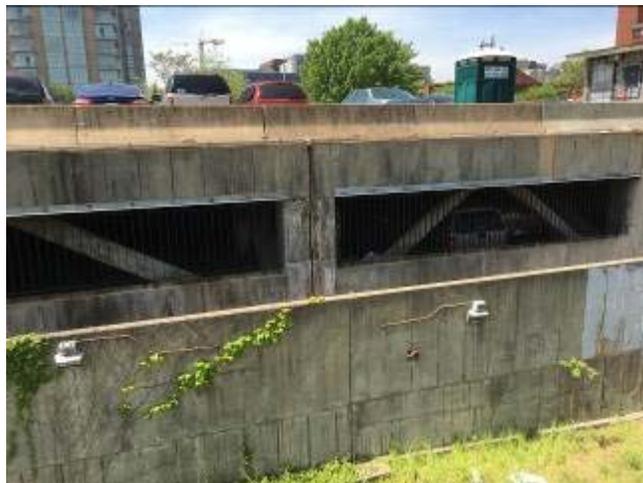
2. There are several cracks in the exterior columns along the east and west faces.

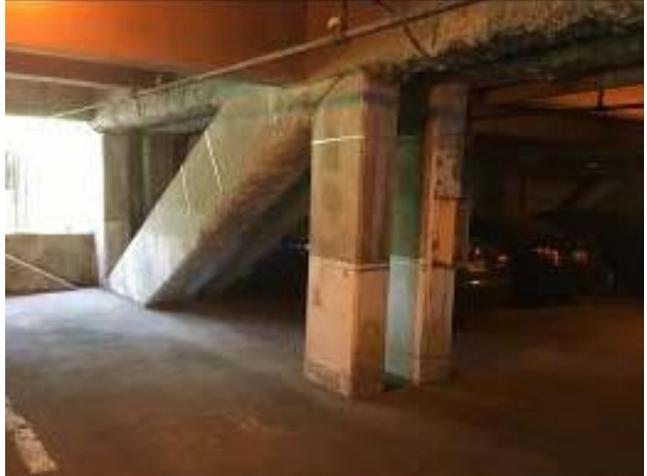
3. Steel straps have been placed around several of the concrete diagonals and columns in the garage.

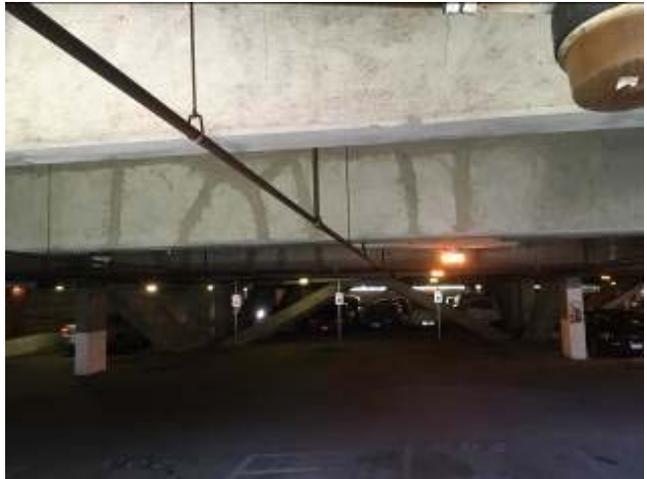
4. There are previous concrete repair patches in many locations.

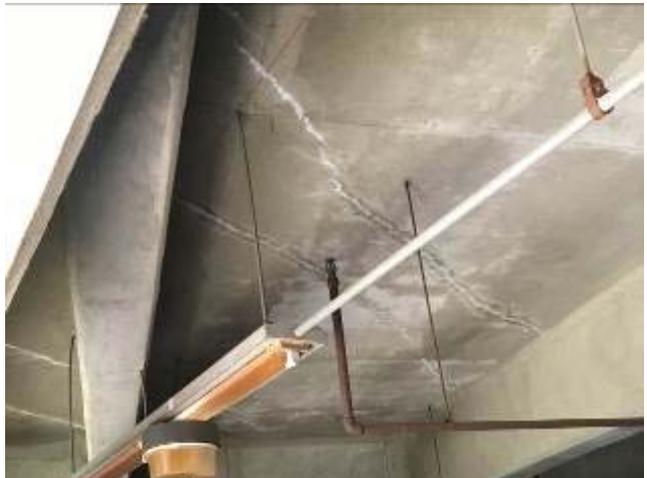
5. There are cracks in the concrete slab under the plaza level.

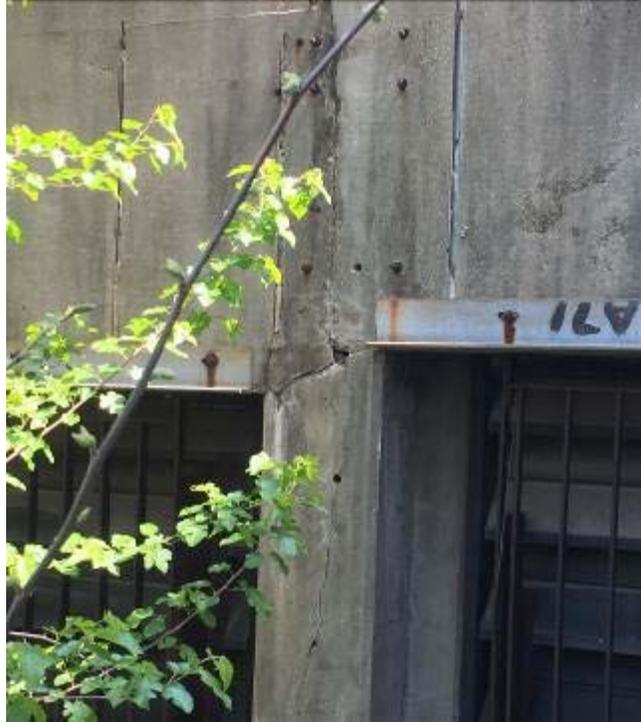
6. In addition to concrete cracking the vertical truss members, there are dovetail slots and existing shelf angles for future brick facing.

The original construction included dove tail slots and brick shelves for support of a future brick veneer around the exterior of the structure. These were not used and have been directly exposed to the elements. The dove tail slots are corroding, so likely cannot be used. The brick shelves appear to be in better condition and may be re-useable. Note that if the concrete fire protection is completely removed, this would also remove both of these items. Installation of new exterior façade supports would need to be coordinated with the future use of the structure.

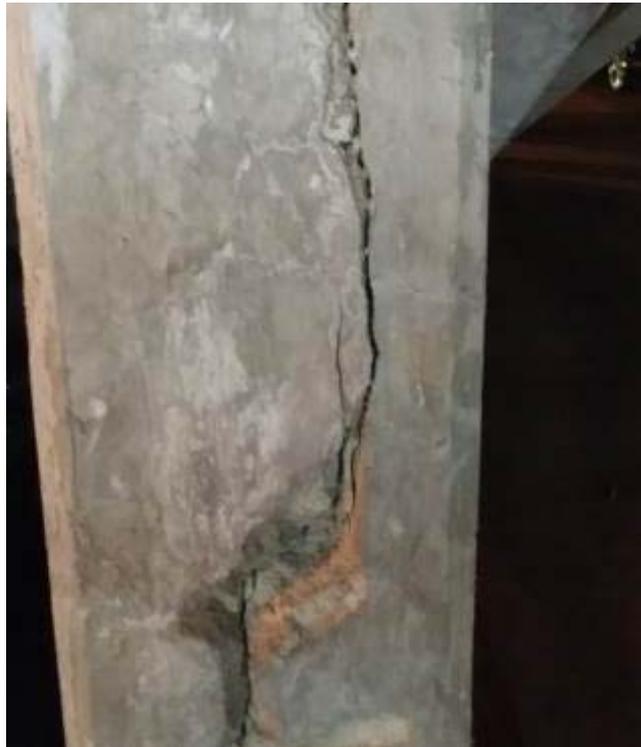
7. There is cracking in the concrete fireproofing cover of the interior vertical truss members.

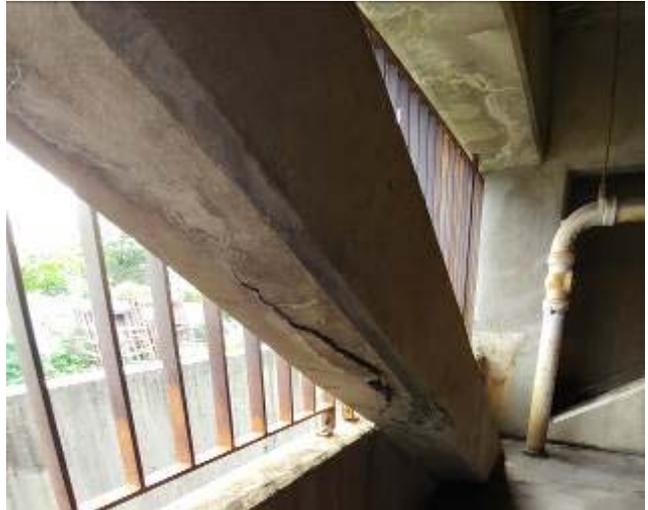
8. There are cracks in the concrete fireproofing cover of the underside of the diagonal members. In addition, there is staining from water on the perimeter beam.

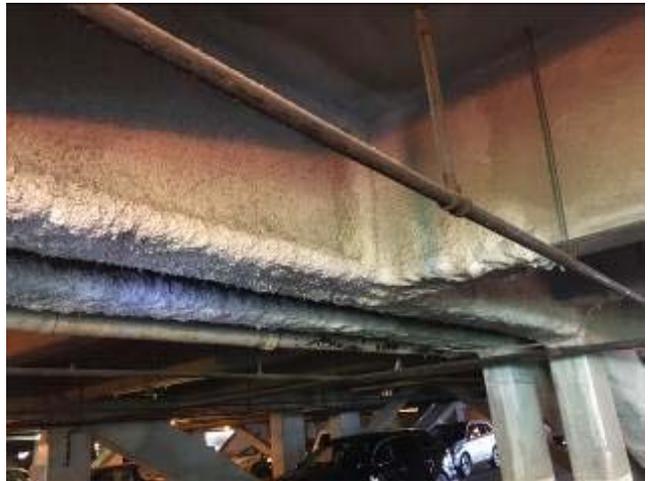
9. There are several locations in the garage where loose concrete fireproofing cover has been removed and replaced with fireproofing

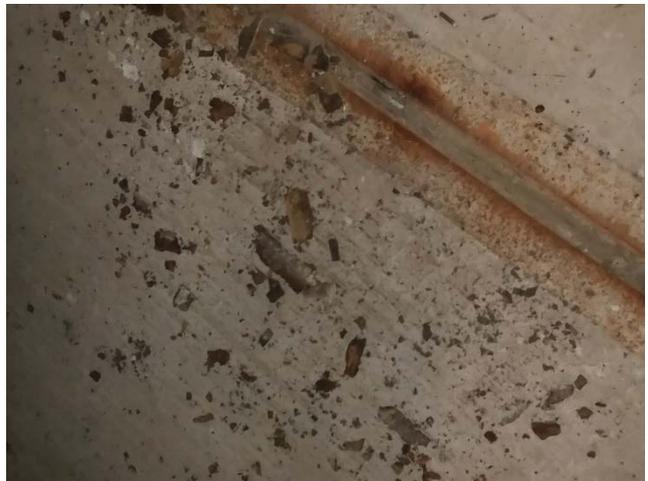
10. There are pieces of corroded steel on the floor of the garage under an area where the concrete cover was replaced with spray on fireproofing.

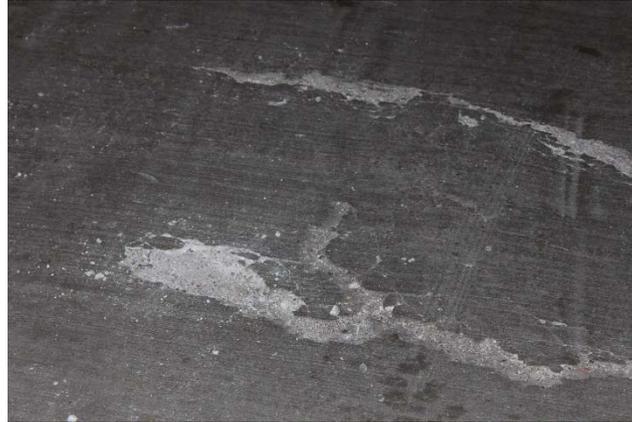
Figure 5. Visible concrete delamination on the slab.

The extent of our delamination survey and approximate size and locations of observed delaminations are shown in Appendix A. Parked cars obstructing access to the slab caused the irregular shape of the survey. In general, the plaza level has fewer and smaller delaminations than the garage level, and no visible spalling. The garage level delaminations are generally larger and most are concentrated in the drive lane south of the entrance/exit ramp. Several of the delaminations have progressed to visible spalls in the garage level slab.

The top deck concrete is relatively in good condition. Minor concrete cut and patch repairs of delaminations should be made prior to building on top since these will become hidden in the future. The expansion joints should be replaced with a better system. These have been ongoing problems and will be much more difficult to repair once any future construction is in place above.

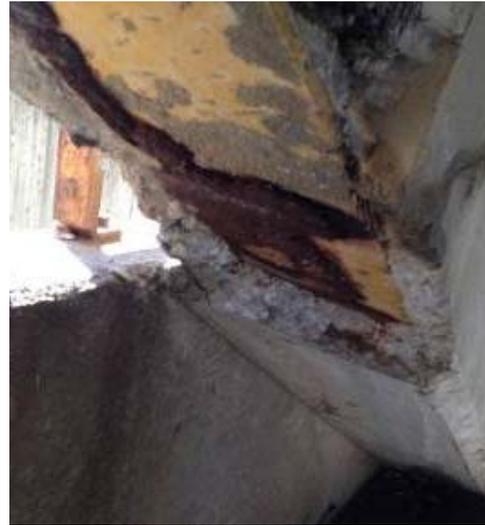
Location A - Diagonal Member:

- Concrete removal description: 12"x12" patch of concrete encasement removed, and additional spalled off during demolition.
- Observations:
 - Bottom flange edge facing exterior corroded along length of diagonal through hollow fire encasement.
 - Original paint (yellow) visible.
 - Rust accumulated at boundary between solid concrete fire encasement and hollow concrete/steel lathe. Rust expansion was measured as 1/8"-1/4".

All existing corrosion must be removed and the remaining steel sections measured. Where there is significant section loss, repairs would likely involve welding on of additional steel plates or sections. At the same time, the existing connections should be inspected with any damaged welds or bolts removed and remediated. From our spot observations, there are likely several locations that need repair.

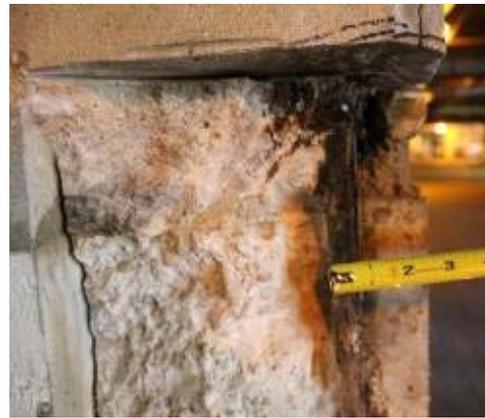
Location B - Vertical Member:

- Concrete removal description: 12"x12" patch of concrete encasement removed at region showing significant rust staining.
- Observations:
 - Efflorescence present at verticals along truss line, indicating water infiltration present at locations. Likely through nearby expansion joint.

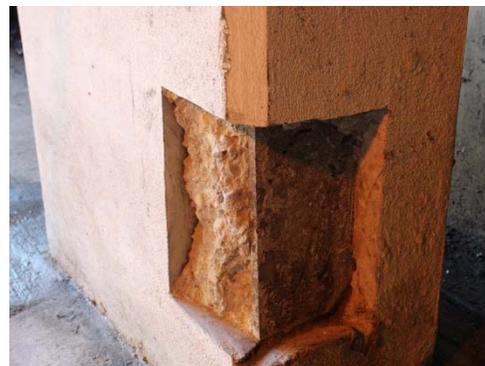
Location C - Vertical Member:

- Concrete removal description: 12"x12" patch of solid concrete encasement removed. Taken as a "control" since encasement did not appear cracked/corroded.
- Observations:
 - No paint observed.
 - Thin rust patina apparent, but no signs of corrosion or rust expansion.

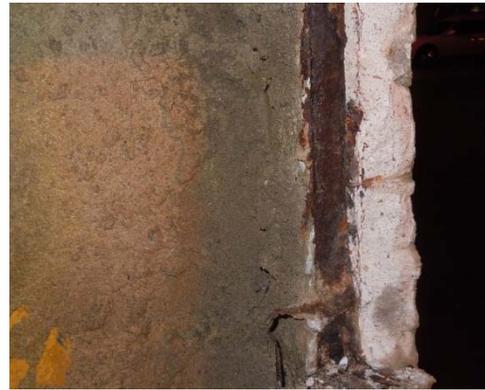
Location D - Vertical Member:

- Concrete removal description: 12"x18" patch of hollow concrete encasement removed. Encasement cracking vertically at corners
- Observations:
 - Thin layer of concrete covers web and inside faces of flanges. Paint visible on column web; no corrosion visible.
 - Wire was tack-welded to column flange at one spot.
 - Looking inside hollow cavity up to the bottom flange of the top chord, some paint and minimal rust is visible. No spalling observed on truss member (no rust flakes accumulated at bottom of hollow cavity).
 - 1/8" rust buildup/expansion on outside flange face.

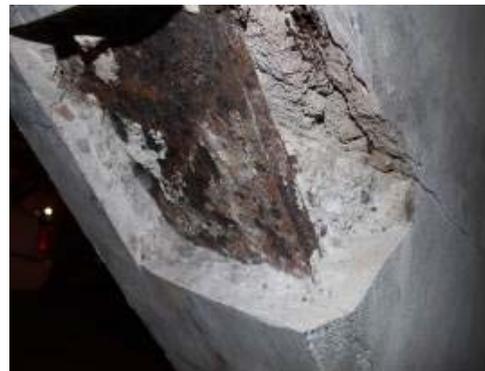
Location E - Diagonal Member:

- Concrete removal description: 12"x12" patch of concrete encasement removed. Encasement cracking along bottom face of diagonal. Cut taken at boundary between solid and hollow encasement (again, site of most cracking).
- Observations:
 - Some efflorescence visible in existing cracks.
 - Rust prevalent in cut section, but not causing major section loss. Mostly pitting. Some rust lines in concrete coming from cracks.
 - Water likely coming from adjacent expansion joint.

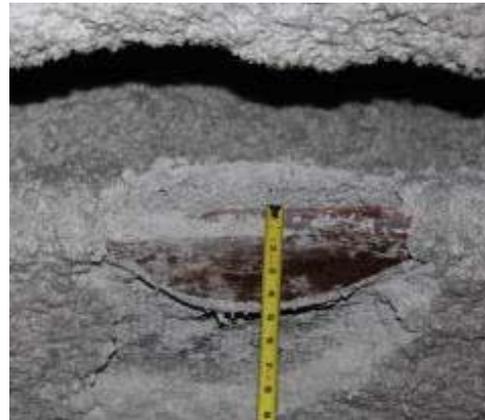
Location F – Top Chord Member:

- Concrete removal description: 12"x12" patch of fireproofing material removed. Section was previously covered in hollow concrete/steel lathe, but was removed and replaced with spray fireproofing material.
- Observations:
 - Rust is prevalent, but not causing major section loss. Mostly pitting. Steel mesh for fireproofing. No rust discoloration in fireproofing.

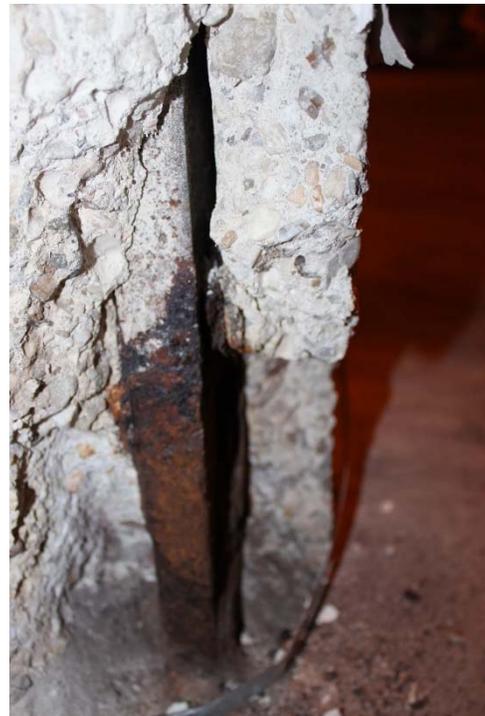
Location G – Vertical Member:

- Concrete removal description: 8"x8" patch of solid concrete encasement. Two (2) bottom corners of vertical encasement could be easily removed by hand (opposite corners, not on same side).
- Observations:
 - Concrete noticeably powdery and white, indicating a chemical reaction deteriorating cement. Paint peeling off easily at base of vertical.
 - Vertical to north exhibits similar degradation at base of column. Slab in proximity to vertical is significantly delaminated.
 - 1/2" thick layer of expanded rust up to 9" tall from finish floor of garage deck.

1. At the transition from the hollow to the solid concrete fireproofing section where water that has penetrated the hollow section is trapped on top of the solid portion.
2. At the bottom of the members where they are most exposed to chlorides from the deck. This condition presented the most severe damaged that we observed (location G).

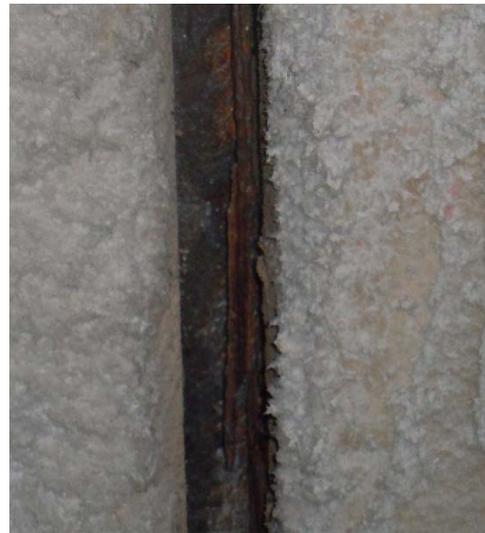
Location I – Expansion Joint:

- Severe rusting of embedded steel angles in joint.
- Section loss is visible in the joint.
- Pieces of expansion joint metal are dropping onto garage level deck.
- Top surface of expansion joint angle is partially painted and in good condition.

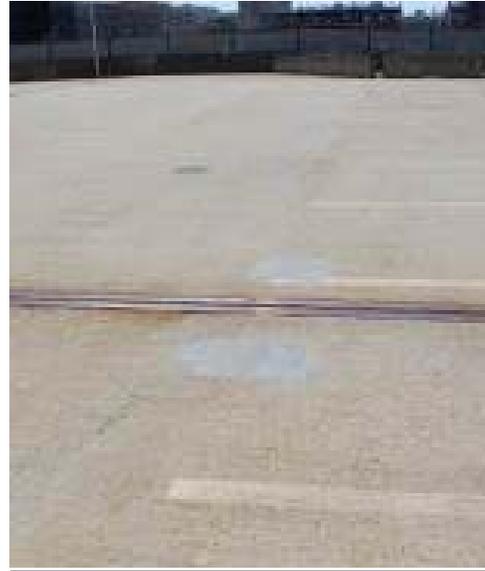
Location J – Repaired Deck Patches:

- Rusting of embedded steel angles in joint.
- Mild section loss is visible in the joint.
- Pieces of expansion joint metal are dropping onto garage level deck.
- Top surface of expansion joint angle is partially painted and in good condition.

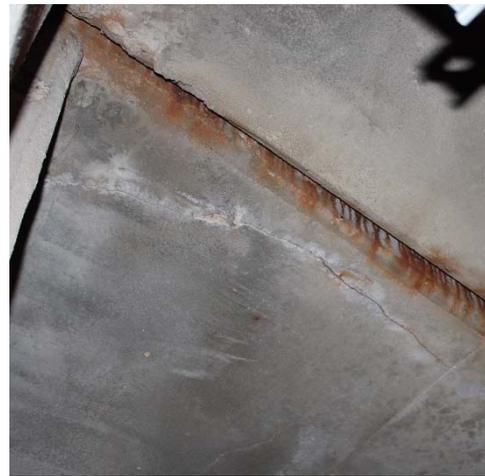
Location K – Crack in Soffit Near Expansion Joint:

- Crack is approximately 5' long.
- Efflorescence visible at crack.
- Crack in proximity to rusting expansion joint.
