Facility Condition Assessment

Chevy Chase Community Center
5601 CONNECTICUT AVENUE NW
WASHINGTON, DC 20015
Date of Report: April 17, 2021

Submitted By:
Spectrum Management, LLC

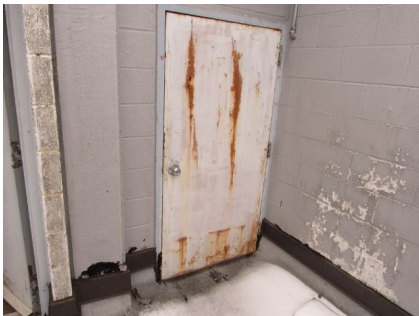
Corroded Door at Roof

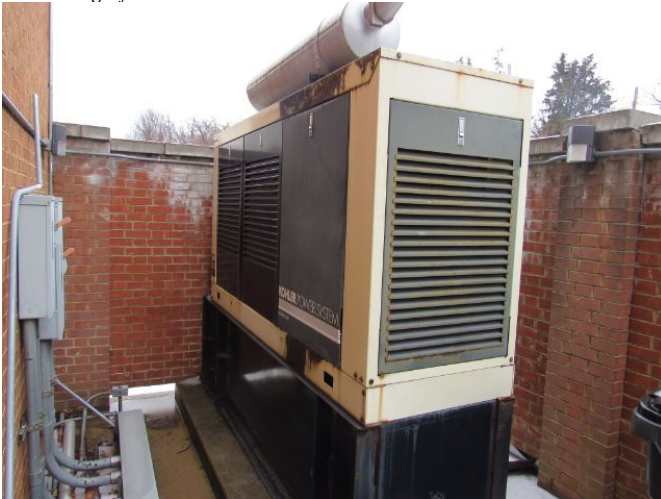
Emergency Generator - General Wear - At-Grade
Emergency Generator - General Wear - At-Grade
March 27, 2021

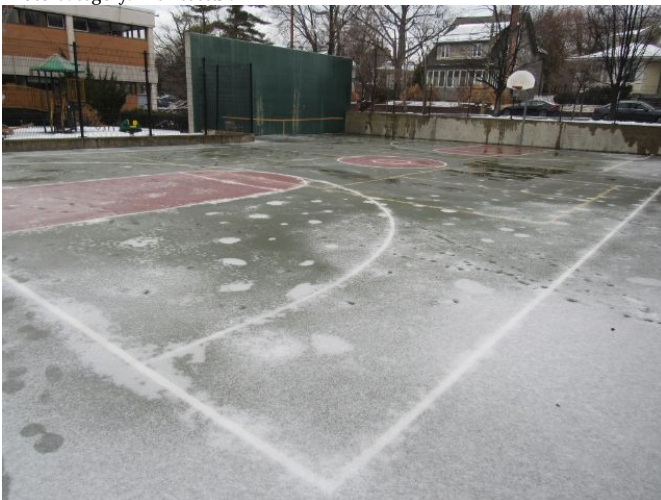
Basketball Court - Color Coat Faded - Exterior
Basketball Court - Color Coat Faded - Exterior
March 27, 2021

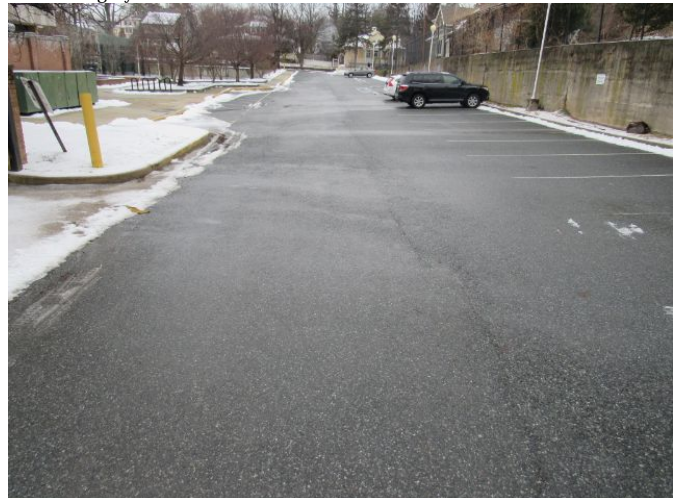
Asphalt Parking Lot & Roadway - Wearing Surface Will Exceed Life - East Elevation
Asphalt Parking Lot & Roadway - Wearing Surface Will Exceed Life - East Elevation
March 27, 2021

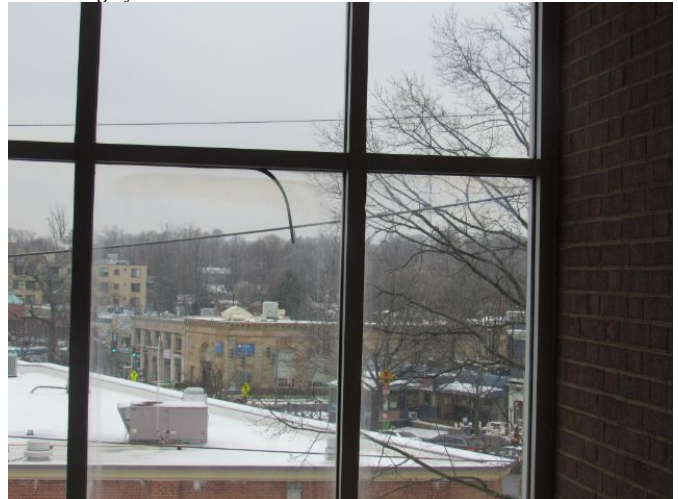
Aluminum Windows
Detached Window Gasket
March 27, 2021

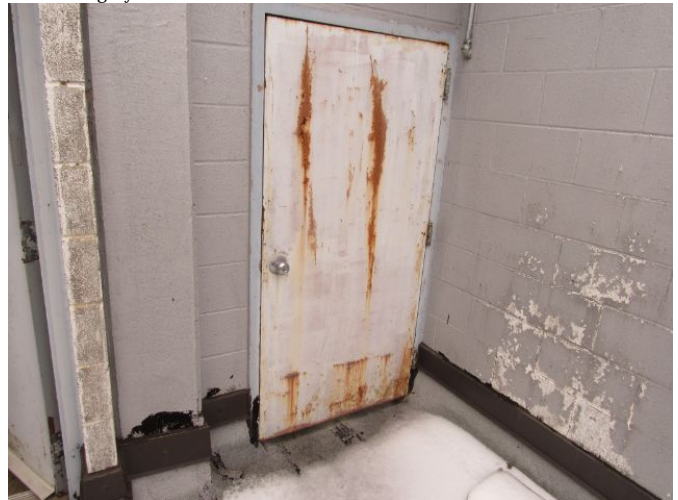
Door Assembly - Single - Hollow Metal (Roof + Generator Enclosure)
Corroded Door at Roof
March 27, 2021

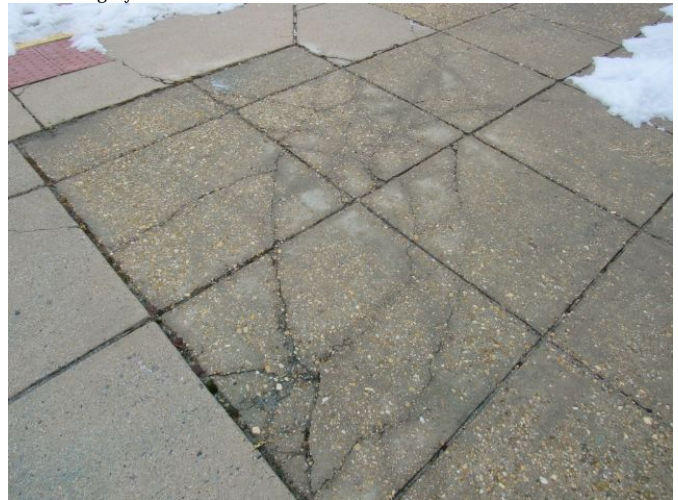
Concrete Sidewalks - Cracked - East Elevation
Concrete Sidewalks - Cracked - East Elevation
March 27, 2021

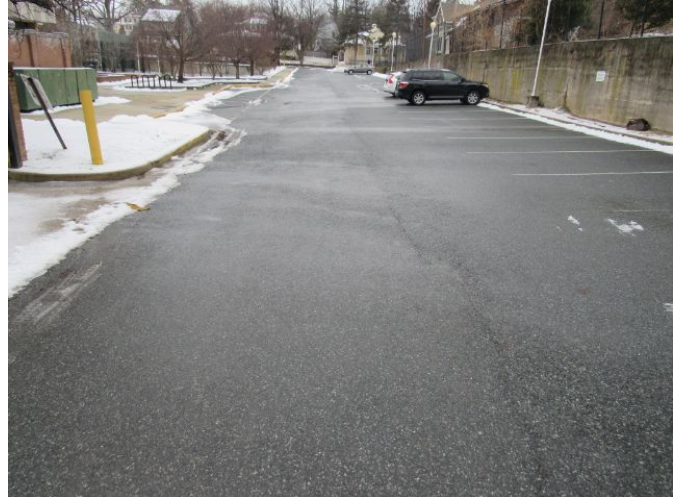
Asphalt Parking Lot - Life Cycle Maintenance - East Elevation
Asphalt Parking Lot - Life Cycle Maintenance - East Elevation
March 27, 2021
