Walter Reed Buildings 31 & 84 - Structural Assessment

October 22, 2019

INTRODUCTION

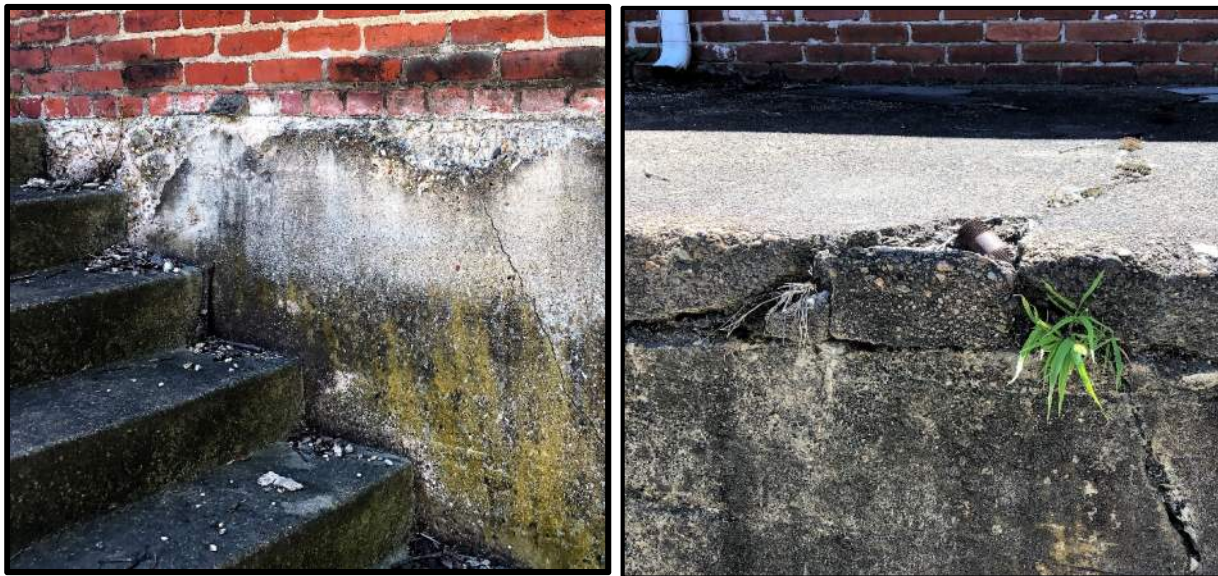
Assessment: Foundation elements were largely hidden and could not be observed. Where visible, foundations were in fair to poor condition. Spalling, cracking and weathering of the concrete platform and exposed foundation walls were observed (see Figure 5). Some weathering and loss of shell thickness was evident at the open storage CMU foundation walls.

Figure 5 Spalling and Cracks at 1921 Foundation Wall (Left) and Cracking/Spalls at North Platform

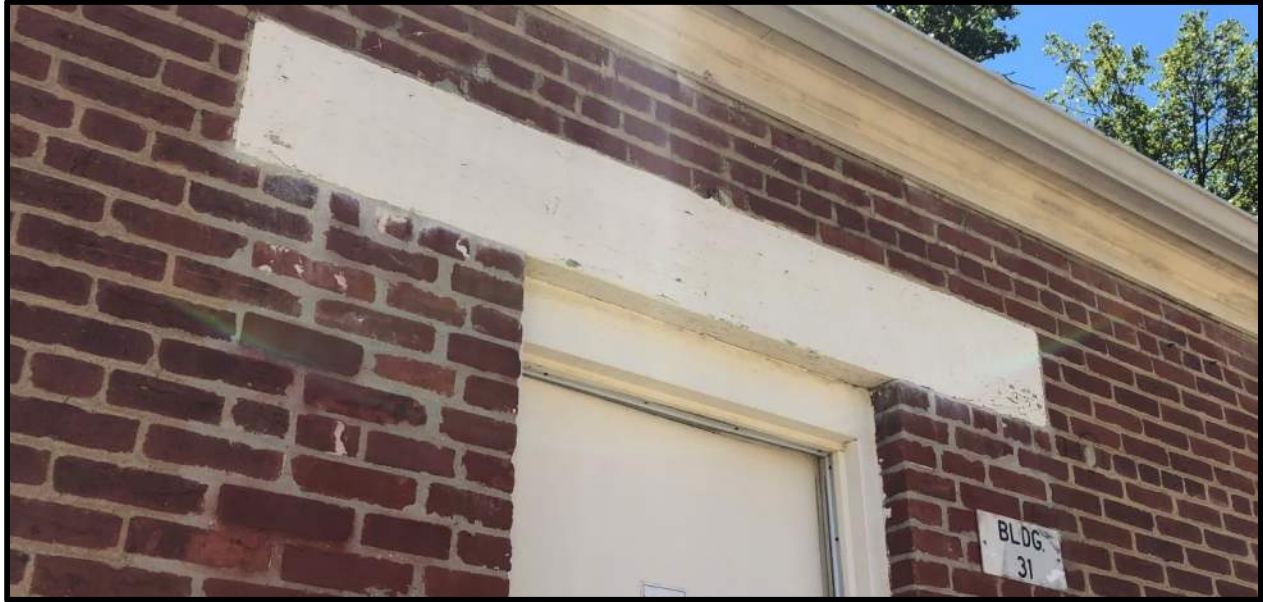
Figure 6 Partially Infilled Opening and Concrete Lintel at Original 1921 Building

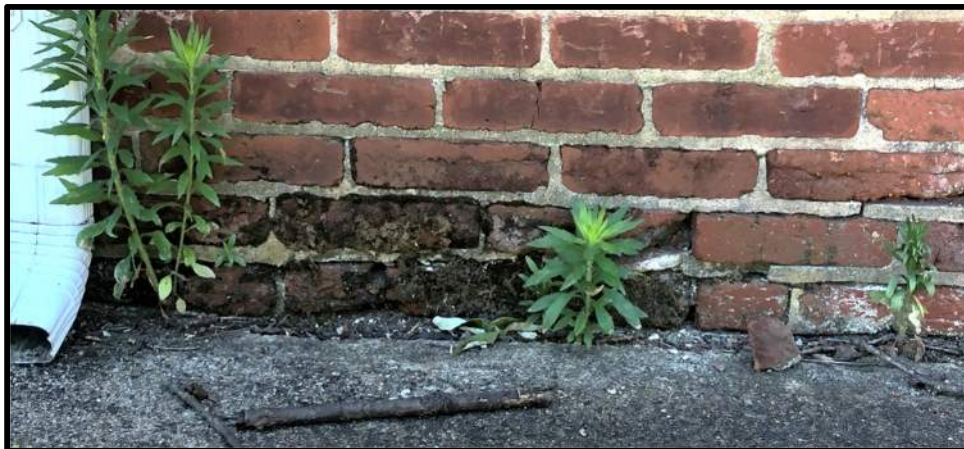
Assessment: Masonry walls are in fair condition. Efflorescence was noted in localized areas and organic growth/mortar loss was evident in walls near grade, likely due to rising damp. Damage was especially prominent near downspouts (see Figure 9).

Figure 9 Mortar Loss and Organic Growth Near Grade

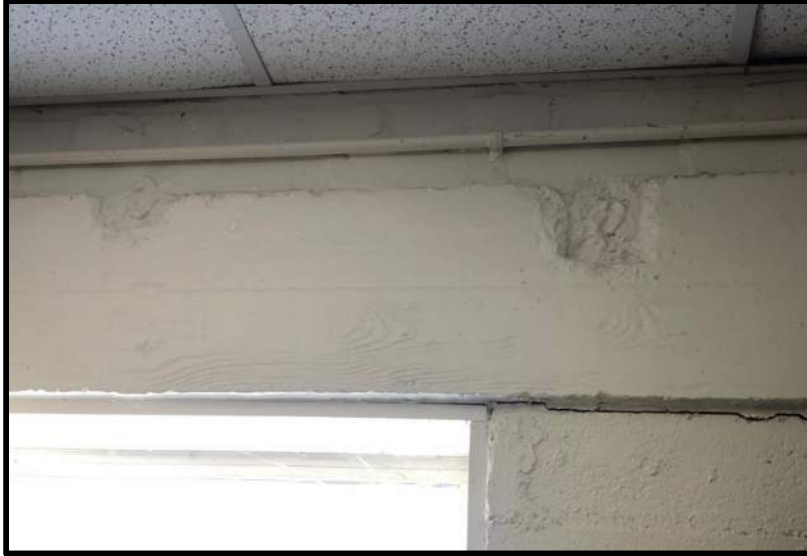
At the 1921 building some masonry cracking and concrete spalling was evident at the inside face of the wall around the lintels (see Figure 10).

Figure 10 Concrete Spalling at Top of Lintel and Cracking Below

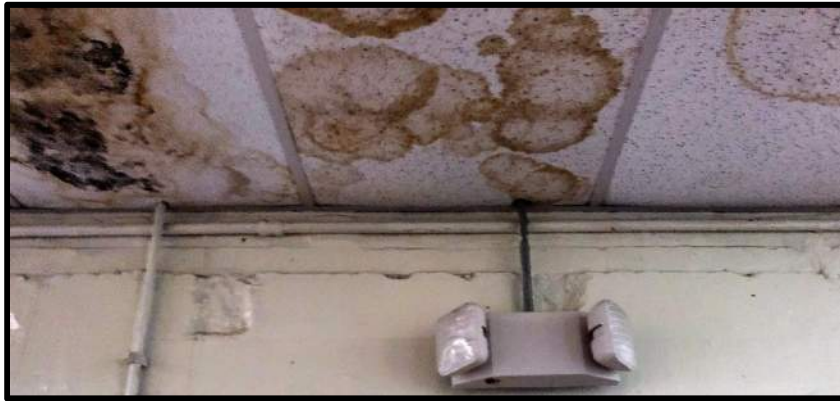
Assessment: Much of the roof framing is obscured by ceiling finishes. Where it could be observed the framing appeared to be in poor to fair condition. There are signs of moisture infiltration at the roof, such as water stains on ceilings, which likely corresponds to wood deterioration in the roof framing.

Figure 12 Water Staining at Dropped Ceiling Tiles

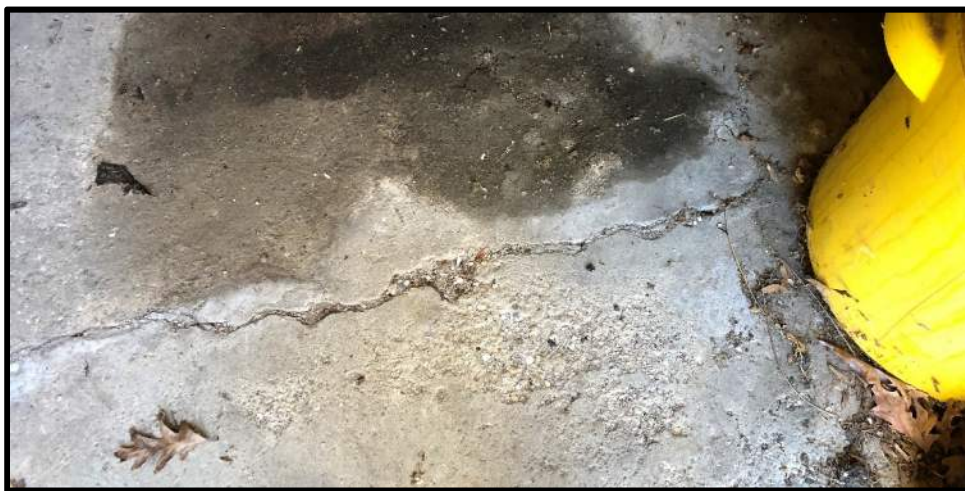
Assessment: Where foundation elements are visible, they are in poor to fair condition. A portion of the north foundation wall is visible at an exterior ramp and has significant concrete loss due to weathering. Cracking was noted at several locations at the slab on grade (see Figure 14).

Figure 14 Cracks and Minor Spalling at Slab on Grade

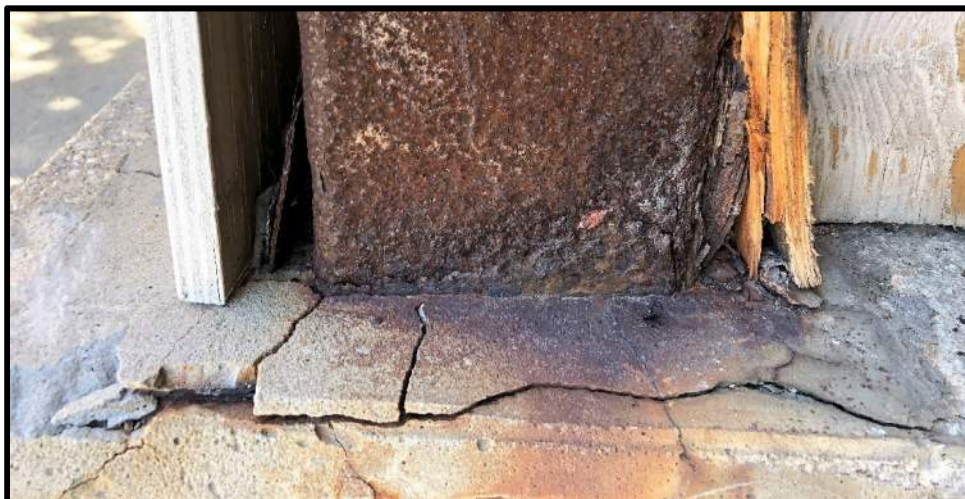
Spalling and cracking was also noted in the concrete foundation walls at the shed where the salt has likely accelerated deterioration due to increased chloride exposure. Cracking is prevalent at the interface with the steel frame where rusting of the steel has displaced the surrounding concrete (see Figure 15).

Figure 15 Spalling of Concrete Foundation Walls at Interface with Steel Frame

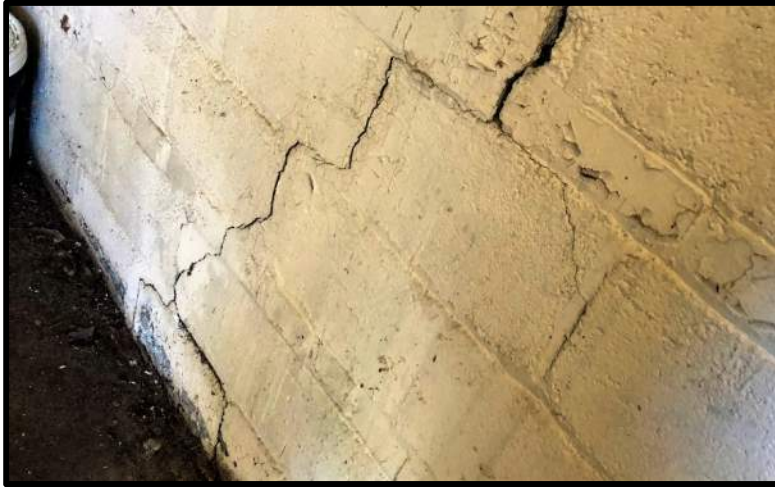
Assessment: The walls at Building 84 are in poor to fair condition. The south elevation above grade is covered in dense vegetation and only limited observations could be made from the exterior. At the original structure step cracking was noted at isolated locations, likely due to foundation shifting and settlement due to the site

grading (see Figure 18). At many locations past anchors and penetrations in the masonry have been patched with incompatible materials causing further distress.

Figure 18 Step Cracking at Masonry Wall

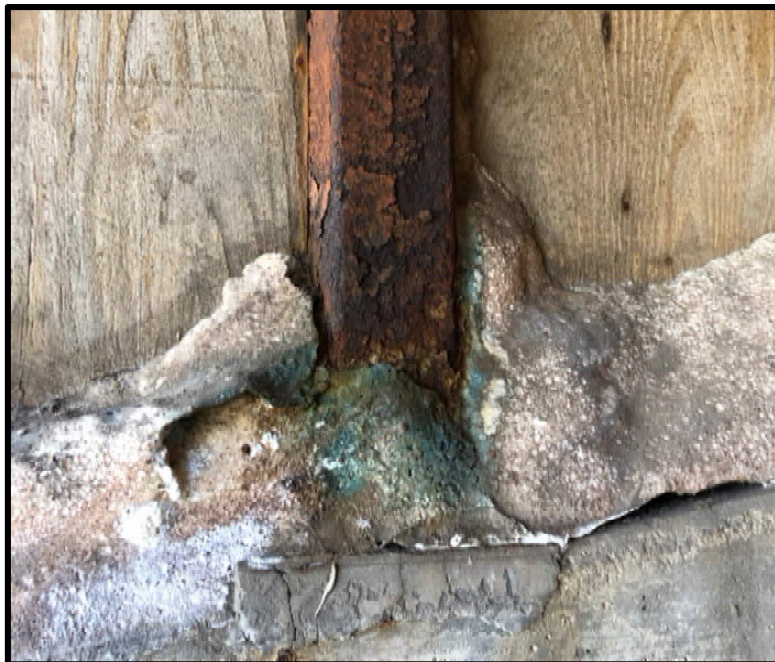
The steel framing and wood infill at the shed addition is in poor condition. Significant rusting has caused section loss of both beam and column members (see Figure 19). The wood plywood sheathing has staining especially near the base at the concrete knee walls. Based on observed conditions it is likely the underlying wood studs and sill plates have also experienced section loss.

Figure 19 Rust at Base of Steel Tube Column

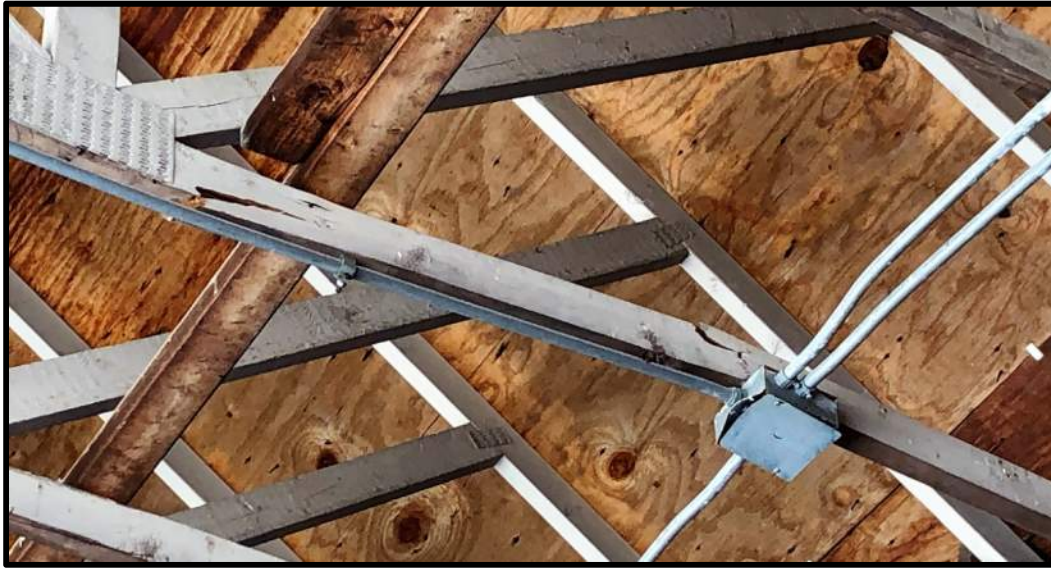
At the shed structure the plywood sheathing had significant water staining. Members could not be assessed up close, but it appears likely that at least some members have section loss. Some of the 2x4 truss members appear undersized for their span and some have failed (see Figure 22).

Figure 22 Failed Bottom Chord of Shed Truss
