REPORT OF COMPREHENSIVE FACILITIES CONDITION ASSESSMENT & SPACE UTILIZATION SURVEY

DISTRICT OF COLUMBIA DEPARTMENT OF FIRE AND EMERGENCY MEDICAL SERVICES ENGINE COMPANY NO. 12 2225 5^{TH} Street, NE Washington, D.C. 20002

PUBLISHED OCTOBER 2009, BY DISTRICT OF COLUMBIA DEPARTMENT OF REAL ESTATE SERVICES ROBIN-EVE JASPER, DIRECTOR GERICK T. SMITH, DEPUTY DIRECTOR OF CONSTRUCTION DIVISION

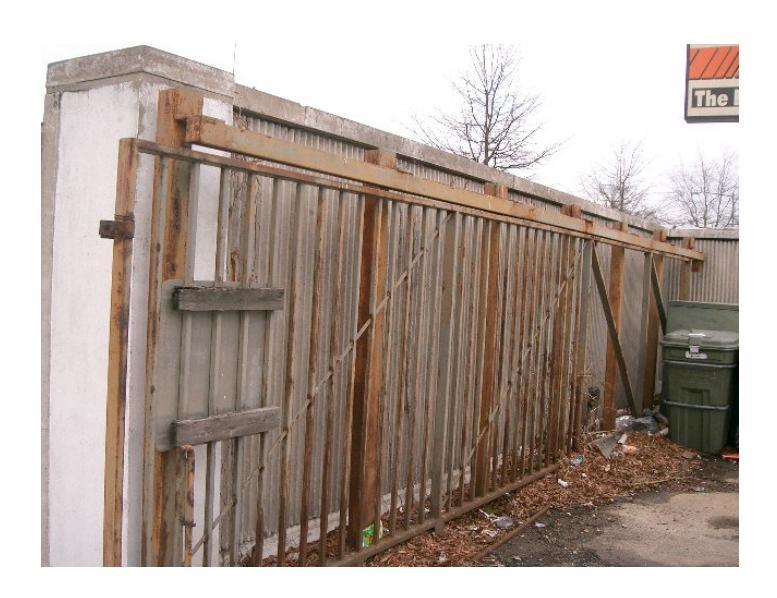
Metal rolling gates at the Rhode Island Avenue NE parking lot entrance requiring repair.

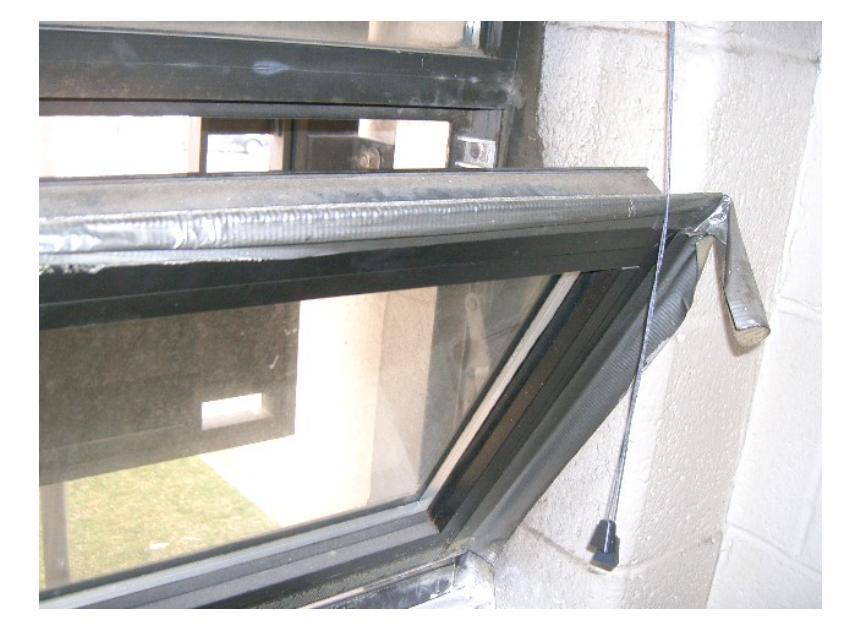
Photograph No. 36

Window systems are generally in good condition, with the perimeter sealants in fair condition (see Photograph 14 in Appendix C). The windows and exterior doors are the original installations, with minor seal damage noted at a limited number of the hopper window sashes (see Photograph 36 in Appendix C). The decorative metal window grilles, also of use for security reasons, are in good condition, but will require repainting during the study term. The grille on a first floor window on the southeast façade was missing and its replacement is

Perimeter seal damaged at the operable sash of an exterior window.

- 7. We recommend replacement of the perimeter sealant at the door and window frames. Our opinion of the costs for this work is \$10,500 (\$13.60 per linear foot)

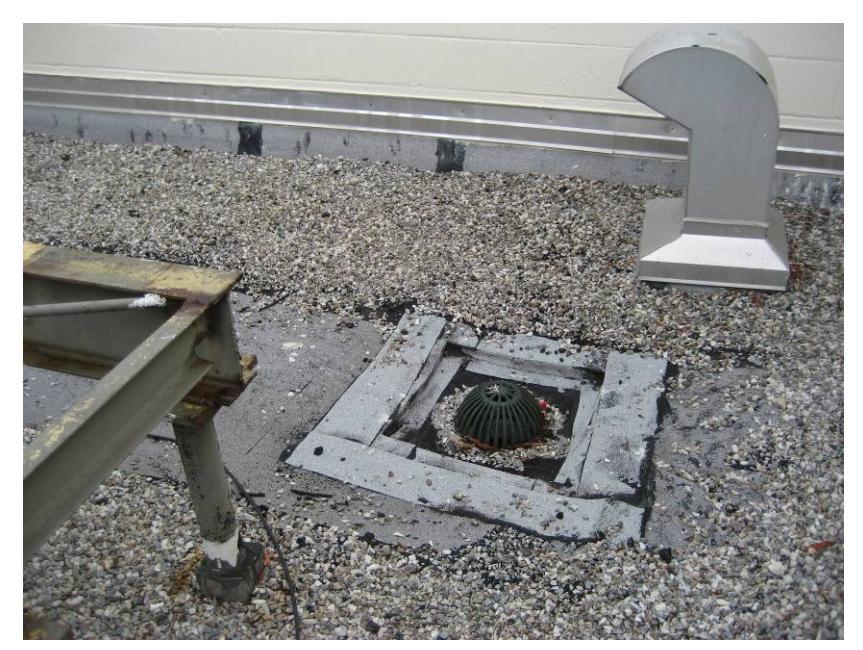
The roof systems appear to be in good condition (see Photograph 4 in Appendix C). However, the on-site personnel reported that patching was recently required around the roof drain in the HVAC enclosure at the southeast corner of the main building roof. The second floor storage room below this roof drain had stained and damaged ceiling tile, indicating that additional patching may be required. The parapet and equipment curb flashing and the parapet's metal cap appeared to be in good condition. We recommend that additional roofing repairs be completed at the main roof's southeastern roof drain and that regular roof maintenance be provided to extend the life of the roofs.

Area of recent roofing repair adjacent to split HVAC system condensing unit.

1. We recommend that roofing field membrane and flashing repairs be completed in the area of active roof leaking at the main roof's southeastern drain. Our opinion of the cost for this work is \$500 (\$5 per square foot).

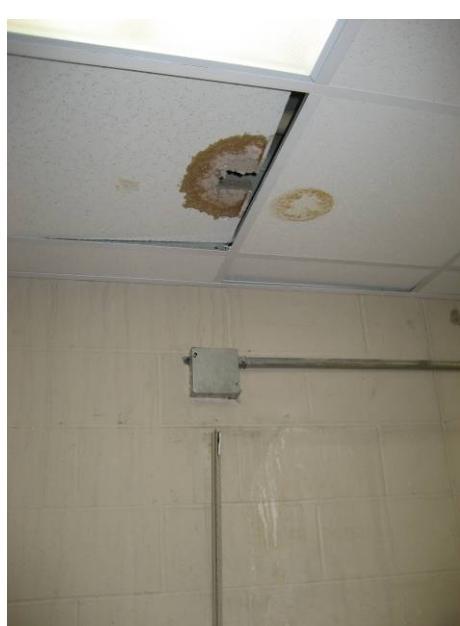
Photograph No. 38

Second floor storage room ceiling below the roof drain shown in Photograph No. 37.

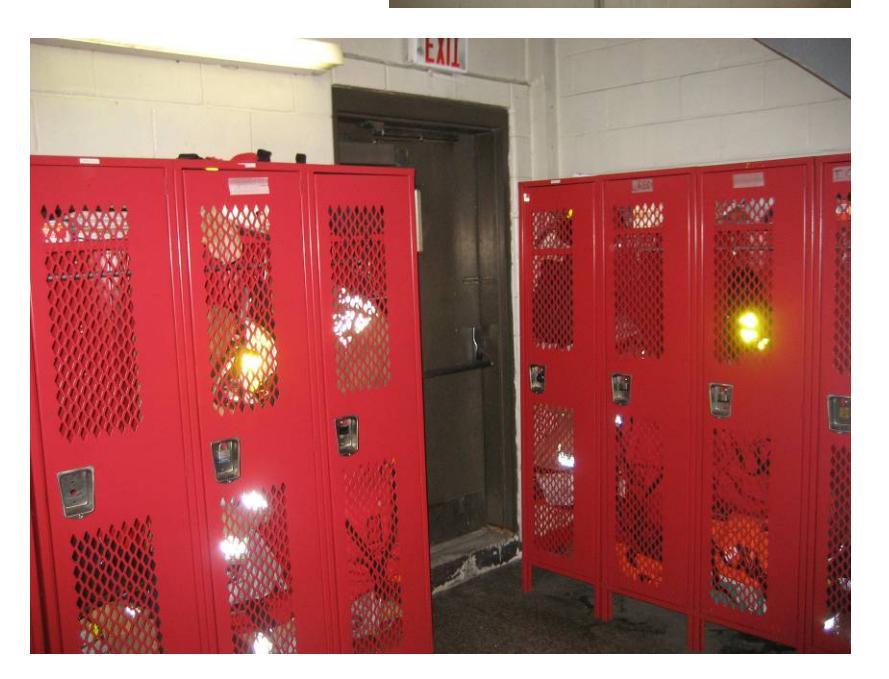
Photograph No. 39

First floor stairwell exit door partially obstructed by lockers.

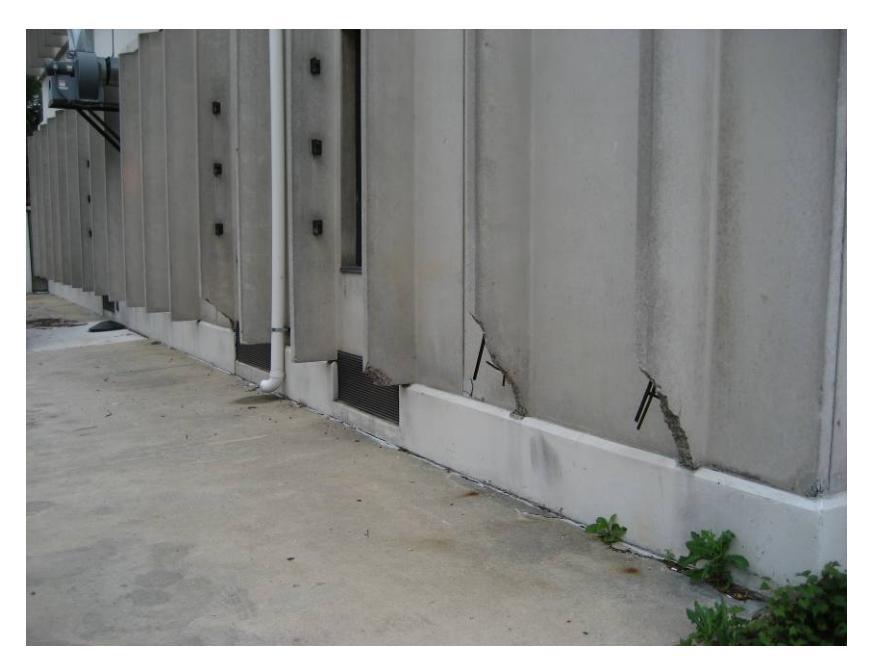
The exterior wall systems are generally in good condition. Items of repair include impact-damaged precast concrete panels at the first floor level of the southeast façade. Vehicles using the adjacent parking area have damaged the bottom corners of the panel projections, exposing reinforcement steel. Other items of repair include faded and peeling paint on the smooth-faced pre-cast concrete panels at the second floor and roof line, minor cracking in the pre-cast concrete panels along their bottom edges and dried and cracking sealant in the joints between panels. We recommended budgeting for near-term repairs to the damaged panels, repainting of the panels at the second floor and roof line and replacement of panel sealants.

Damaged pre-cast concrete panels at the side of the building.

We recommend repairs be completed to the pre-cast concrete façade panels, at locations of vehicle impact damage and at minor locations of spalling or cracking in the panels. At the locations of vehicle damage, we recommend removal of damaged concrete, cleaning of the adjacent surfaces and reinforcement steel, installation of any necessary additional reinforcement and forming and pouring of replacement concrete.

At locations of minor panel damage, patching with epoxy grout is recommended. Our opinion of the cost for this work is \$4,805 (\$34.32 per square foot) for concrete repairs. To prevent additional damage to the wall panels, we recommend installation of concrete-filled steel pipe bollards along the wall to prevent vehicle contact. Our opinion of the cost for this work is \$2,400 (\$600 each) for installation of bollards. Total cost for these repairs is \$7,205.
