DMPED PARKING DECK STRUCTURAL INVESTIGATION

Prepared by: **McMullan & Associates, Inc.**
M&A Project No. 3767

DRAFT SUBMISSION
SEPTEMBER 2, 2016

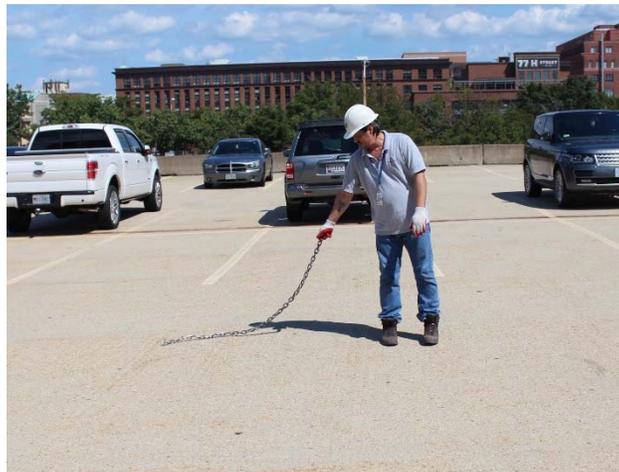
Figure 4. Chain drag sounding on the concrete slab.

Areas of both the upper and lower decks were sounded by chain drag (Figure 4) to determine the approximate size and extent of concrete delaminations. These occur when the steel reinforcing bars corrode and expand, forcing the concrete above to separate. A “hollow” sound is created when the chain is dragged across the concrete surface. As the corrosion gets worse, delaminations progress to visible spalls which eventually break off from the slab (Figure 5).

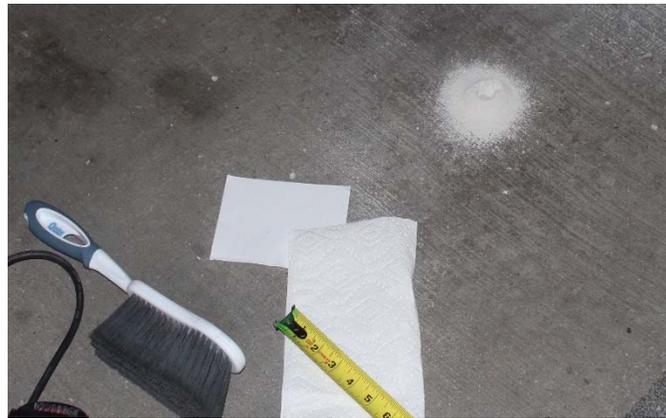
Figure 6. Concrete powder sample for chloride testing.

Concrete powder samples for chloride testing (Figure 6) were taken at eleven (11) locations to represent the full range of structural conditions (Appendix A). Descriptions of the sample locations are provided below:

Samples were delivered to Concurr, Inc. for laboratory analysis, the results of which are presented in Appendix B. Overall, results range from 15 ppm to 4994 ppm, but breaking the result out by area proved to be informative. At the plaza level slab, results range from 20 to 123 ppm. At the garage level slab, they vary from 34 to 2219 ppm. The highest results are in a sample taken from the lower (solid) section of a vertical truss member that was spalling (4994 ppm). All of the high concentration results are at shallow depths in the concrete, while chloride penetration deeper into the concrete (2.5” to 3.5” depth) is generally much lower, ranging only from 20 to 85 ppm.

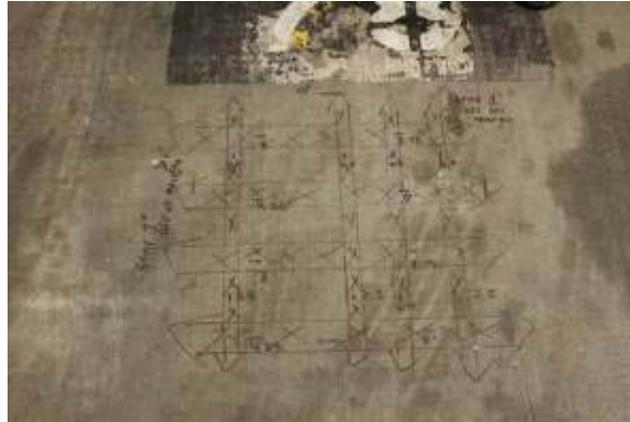
Figure 7. Markings of reinforcement in slab found using GPR.

Ground Penetrating Radar was used to locate reinforcing steel within the concrete slab (Figure 7). The testing showed that the reinforcing layout was generally as indicated in the drawings.

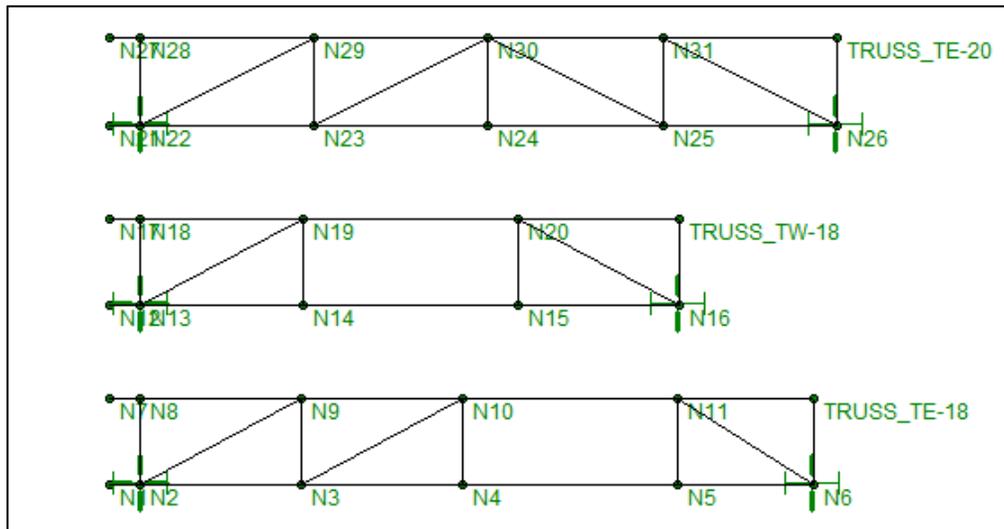
Figure 8. Truss analysis in RISA 3D.

For the analysis, the trusses were modeled using finite element analysis (FEA) software RISA 3D (Figure 8). The existing dead loads from the reinforced concrete slab, plaza beams with fireproofing, and garage beams were applied as uniform line loads to the respective top and bottom chords of the truss. The weight of the ceiling, hung from the bottom chord of the trusses, was applied as a uniform existing dead load to the bottom chord. The self-weight of the truss members and the fireproofing of the trusses were also included as an existing dead load. A uniform live load of 40 psf was applied to the lower chord (garage level) of the truss. To determine the superimposed load capacity of each truss, we increased the superimposed load applied to the top chord (at the plaza level) until the material strength (obtained from the original construction drawings) was reached. The maximum allowable superimposed load for each truss analyzed are presented in Table 1.

Structural Component	Maximum Superimposed Load (psf)
Plaza concrete slab	400
Plaza beam	130
Truss Type A	120
Truss Type B	220
Truss Type C	120

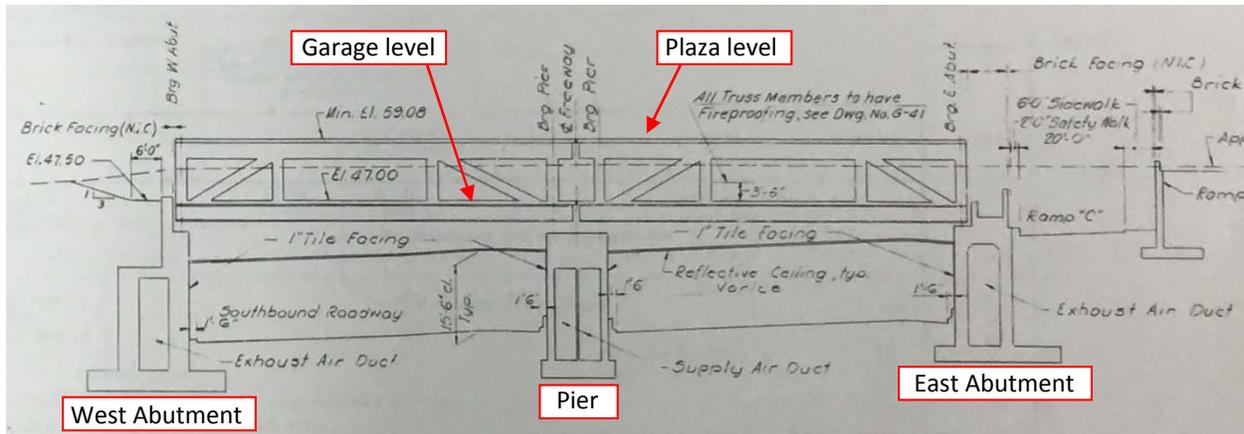
Figure 9. Abutments and pier shown in typical section.

Lastly, we calculated the soil bearing stress under the abutments and piers for the existing condition and compared it to the condition under maximum superimposed load of 120 psf for geotechnical adequacy (Figure 9). The loads listed below were used to calculate the soil bearing stress for each condition:

The reactions at the trusses were distributed at a 1:1 vertical to horizontal ratio down to the footing, with a maximum distributed width equal to the tributary area of the truss. These results of the bearing stress analysis are presented in Table 2. The maximum bearing stress due to existing and superimposed loading was calculated as 5.9 ksf at the pier, with an 11% increase from existing loads. GeoCapitol confirmed that this is acceptable.

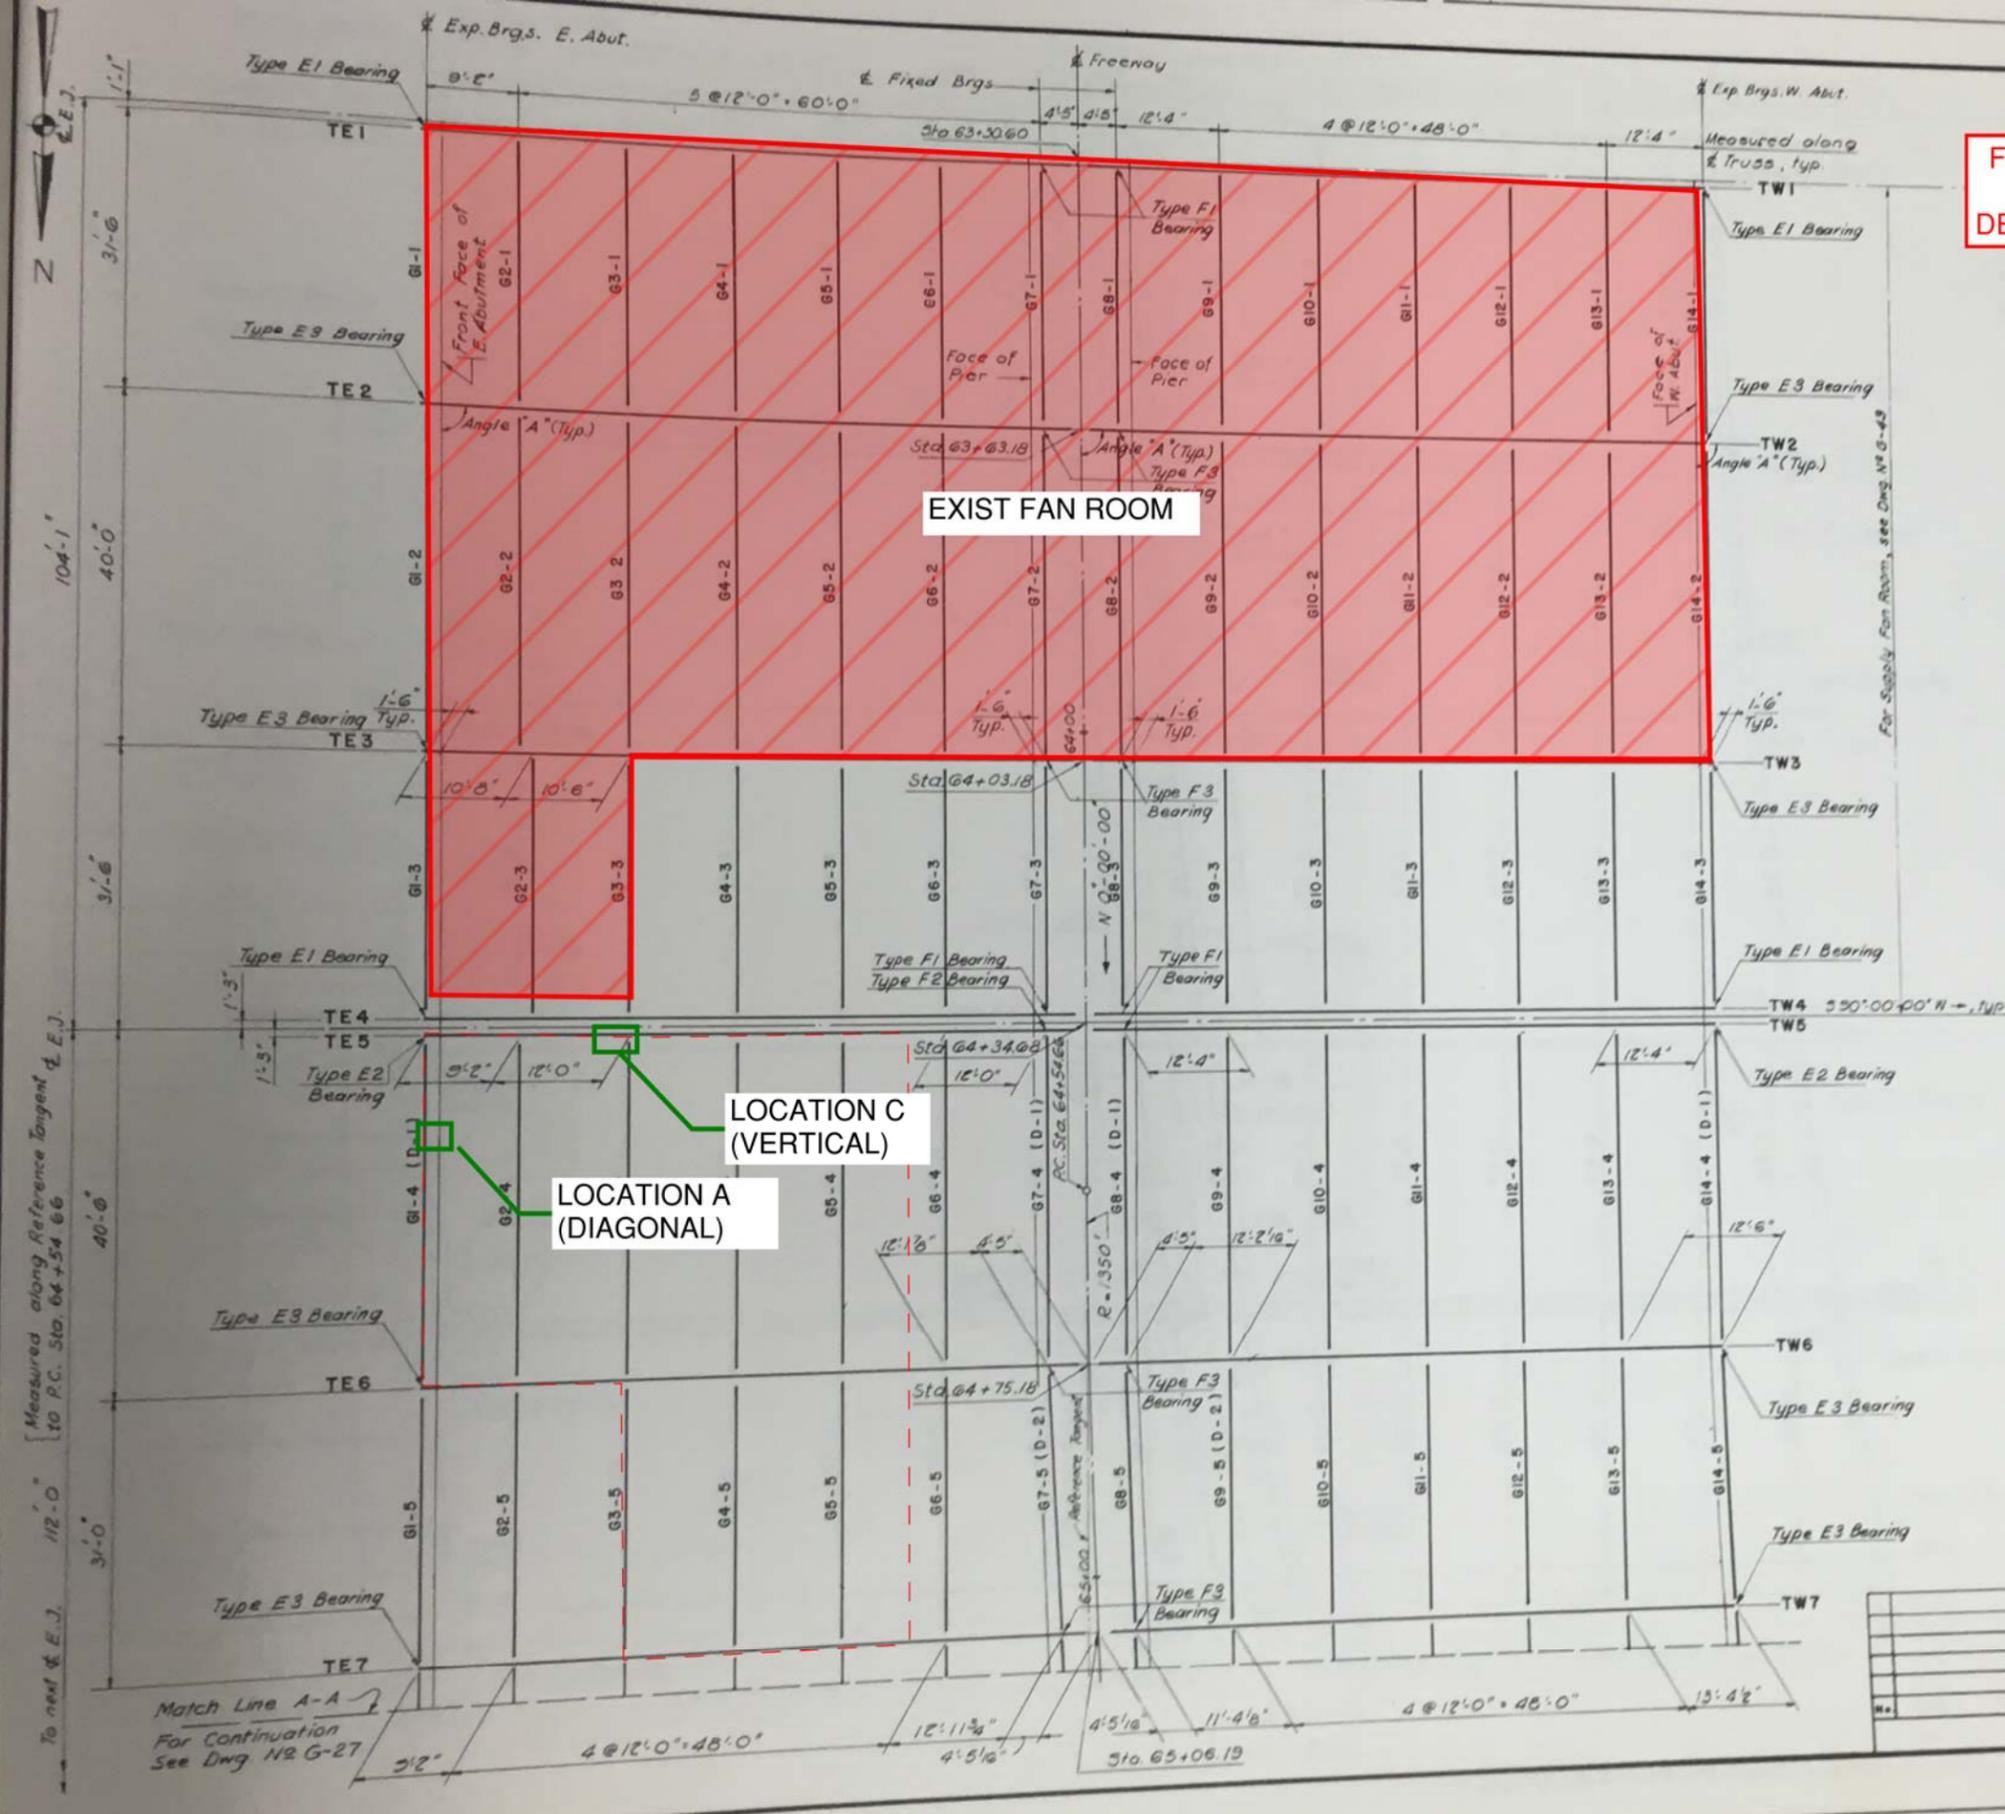
FIGURE 1: GARAGE FRAMING AND DELAMINATION PLAN

The extent of our delamination survey and approximate size and locations of observed delaminations are shown in Appendix A. Parked cars obstructing access to the slab caused the irregular shape of the survey. In general, the plaza level has fewer and smaller delaminations than the garage level, and no visible spalling. The garage level delaminations are generally larger and most are concentrated in the drive lane south of the entrance/exit ramp. Several of the delaminations have progressed to visible spalls in the garage level slab.
