Facility Condition Assessment

Chevy Chase Community Center
5601 CONNECTICUT AVENUE NW
WASHINGTON, DC 20015
Date of Report: April 17, 2021

Submitted By:
Spectrum Management, LLC

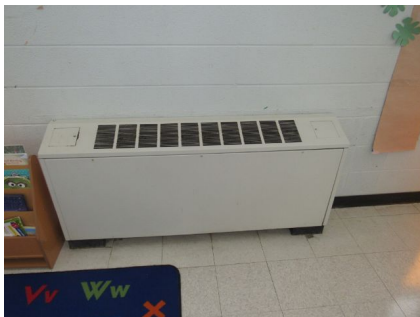
Vertical Fan Coil Floor Mounted (56") - (Original Installation)

Fan coil units were in fair to poor condition with corrosion noted at drip pans and fin deterioration noted. Replacement should be completed in the near-term.

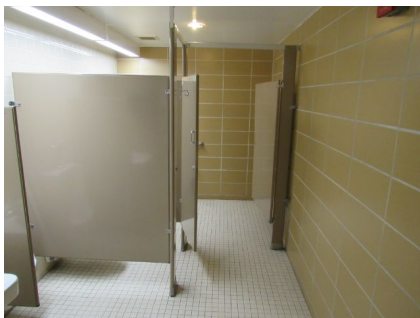
Ceramic Floor Tile (Restrooms)

Tiles in fair to good condition. Budget for restroom refurbishment project towards the end of the 10 year study period. Refurbishment project should include for replacement of tiles.

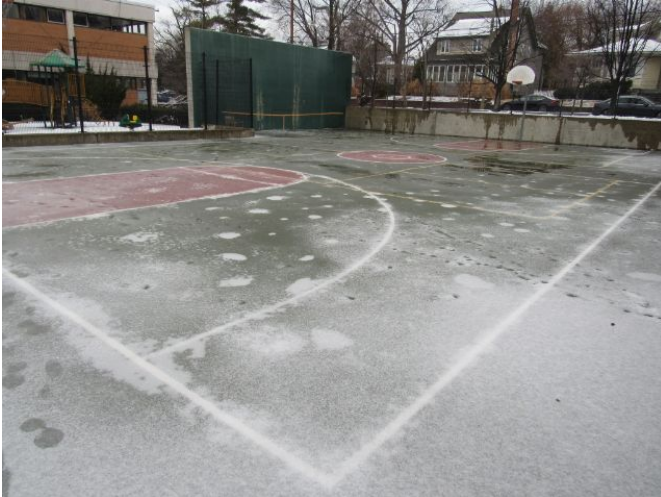
Basketball Court - Asphalt Surface will Exceed Life - Exterior
Basketball Court - Asphalt Surface will Exceed Life - Exterior
March 27, 2021

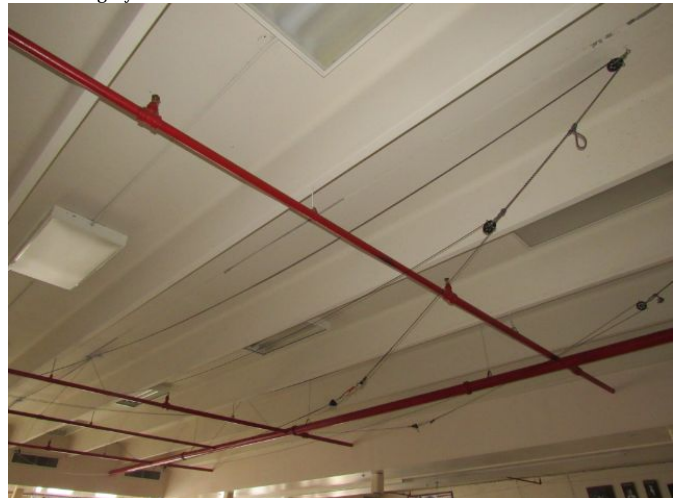
Concrete Superstructure
Concrete Superstructure
March 27, 2021

The structural system appeared to be in good condition.

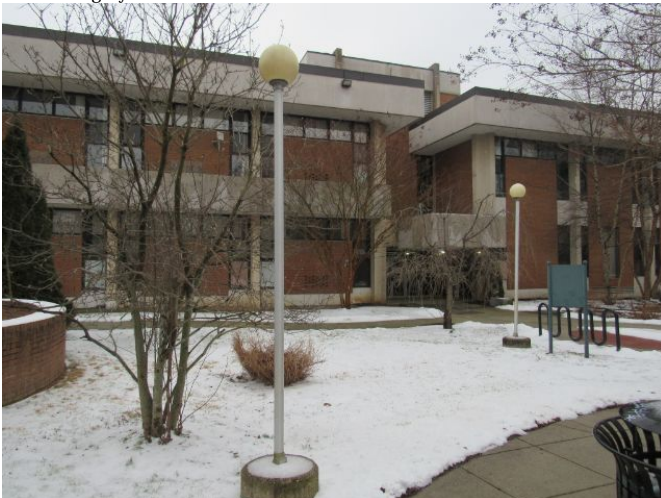
Lighting - Exterior - Pole-Mounted - HID - 10'
Lighting - Exterior - Pole-Mounted - HID - 10'
March 27, 2021

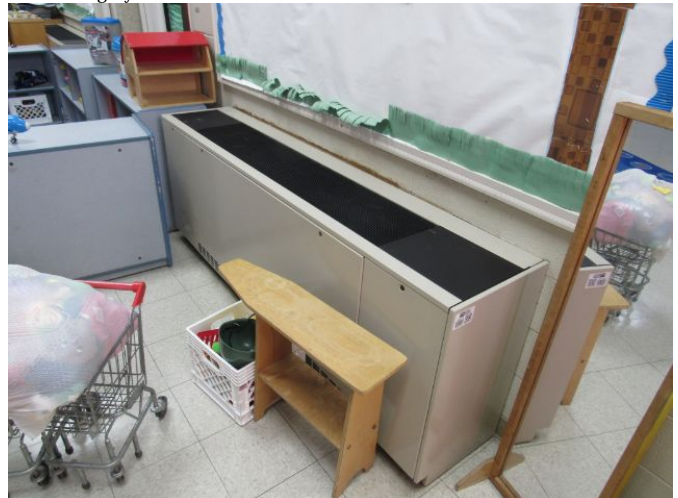
Vertical Fan Coil Floor Mounted (100") - (Original Installation)
Vertical Fan Coil Floor Mounted (100") - (Original Installation)
March 27, 2021

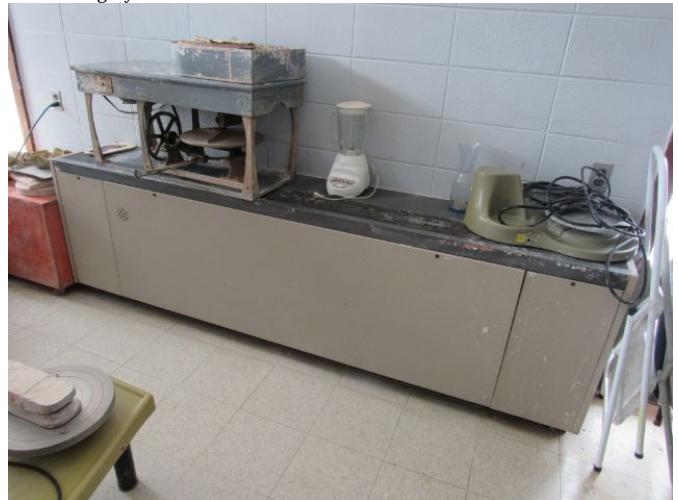
Vertical Fan Coil Floor Mounted (100") - (1999 Installation)
Vertical Fan Coil Floor Mounted (100") - (1999 Installation)
March 27, 2021

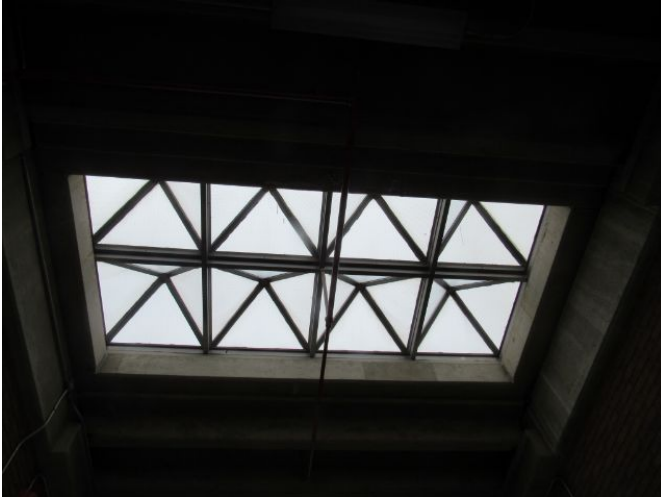
Skylight
Skylight
March 27, 2021

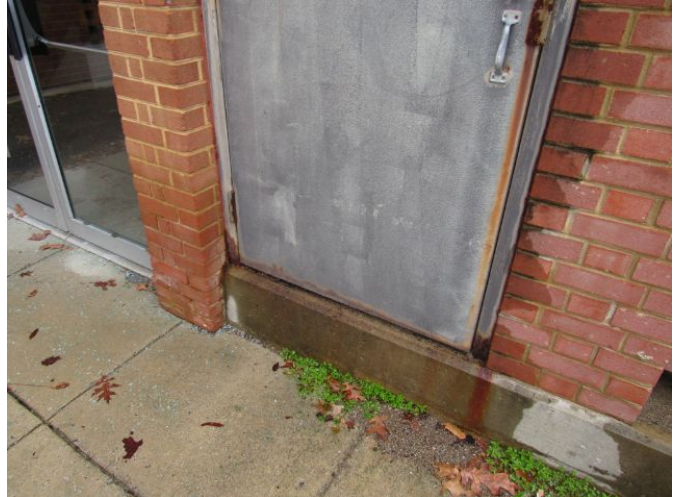
Door Assembly - Single - Hollow Metal (Roof + Generator Enclosure)
Door Assembly - Single - Hollow Metal (Roof + Generator Enclosure)
March 27, 2021

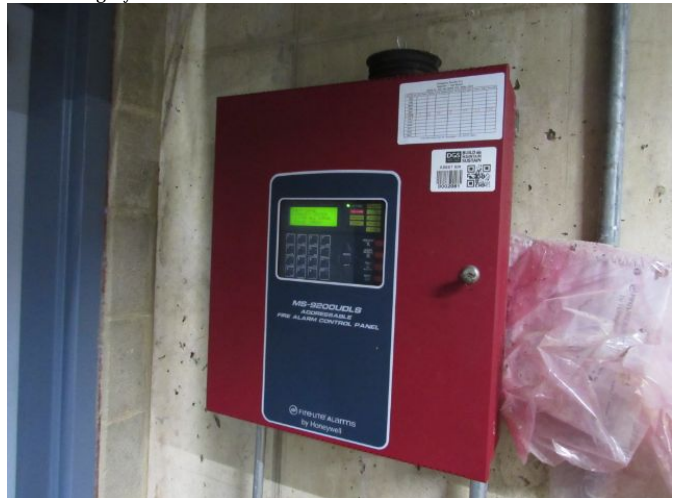
Fire Alarm System - FACP
Fire Alarm System - FACP
March 27, 2021

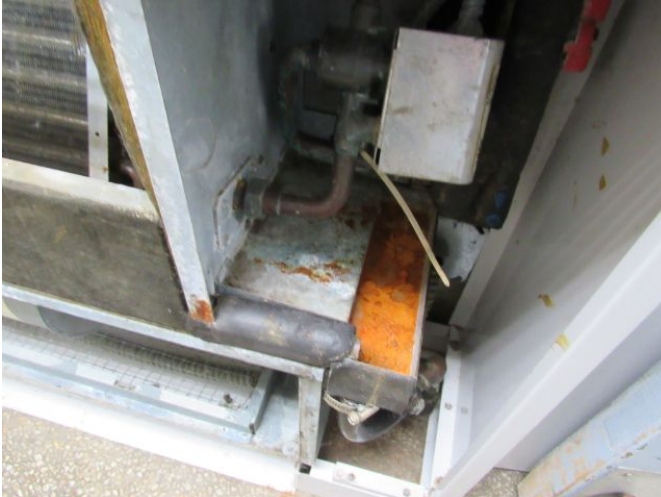
Piping Distribution - 2 Pipe - Hot / Chilled / Condenser Water
Piping Distribution - 2 Pipe - Hot / Chilled / Condenser Water
March 27, 2021

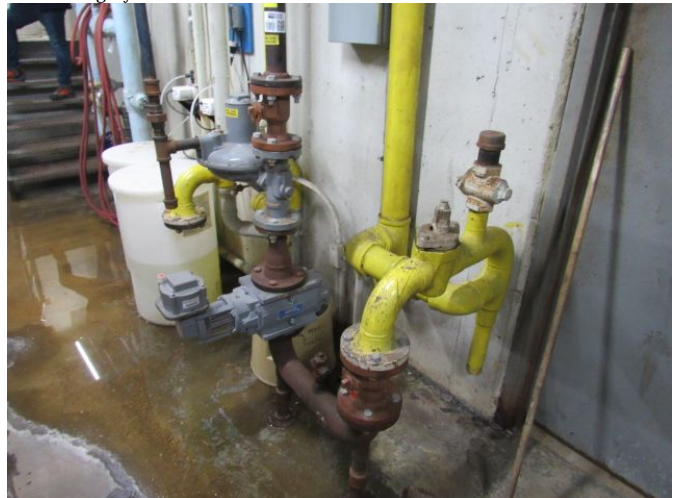
Natural Gas Supply for Bldg - 3" Feed
Natural Gas Supply for Bldg - 3" Feed
March 27, 2021

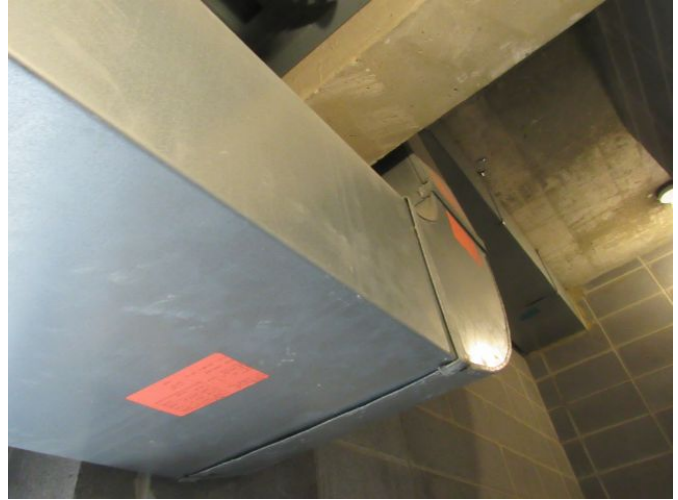
HVAC Ductwork - Supply - Multi-Zone
HVAC Ductwork - Supply - Multi-Zone
March 27, 2021

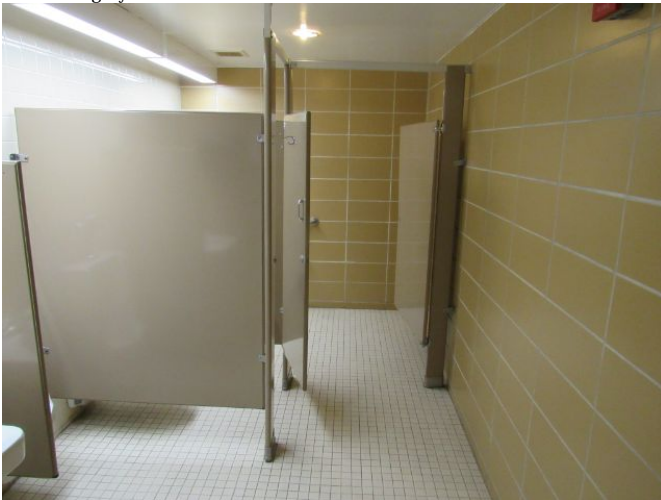
Restroom Fixtures - Multi-Stall Restrooms
Restroom Fixtures - Multi-Stall Restrooms
March 27, 2021
