REPORT OF COMPREHENSIVE FACILITIES CONDITION ASSESSMENT & SPACE UTILIZATION SURVEY

DISTRICT OF COLUMBIA DEPARTMENT OF FIRE AND EMERGENCY MEDICAL SERVICES ENGINE COMPANY NO. 12 2225 5^{TH} Street, NE Washington, D.C. 20002

PUBLISHED OCTOBER 2009, BY DISTRICT OF COLUMBIA DEPARTMENT OF REAL ESTATE SERVICES ROBIN-EVE JASPER, DIRECTOR GERICK T. SMITH, DEPUTY DIRECTOR OF CONSTRUCTION DIVISION

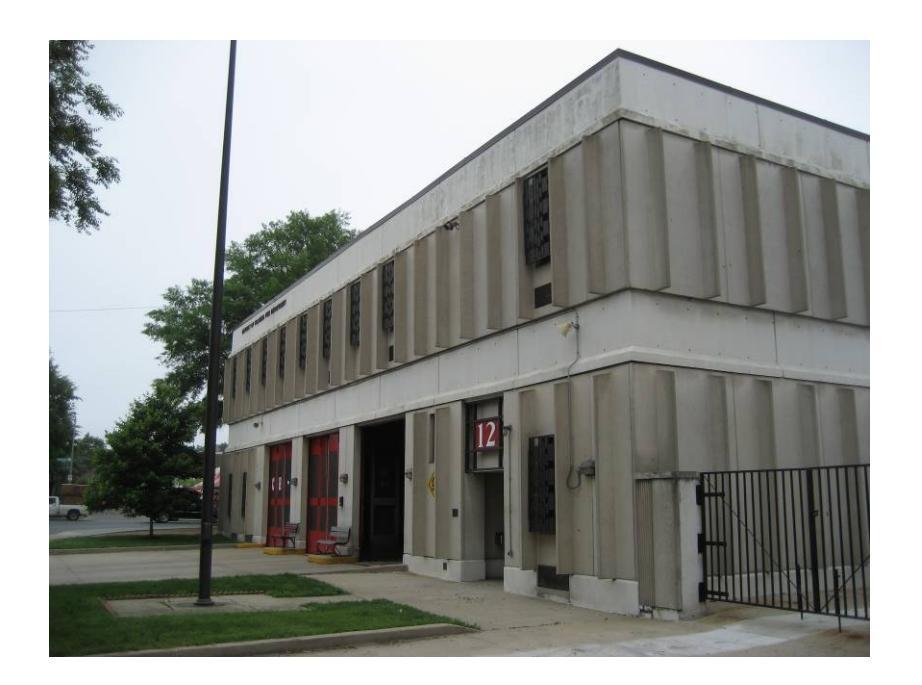
Photograph No. 1

The windows were provided with limited blast shrapnel protection (see Photograph 1 in Appendix C) by the security grilles, but the glazing is typical thermal pane material and does not provide blast shrapnel protection.

Front elevation facing 5thStreet, SE with three doors to apparatus bay, and gate to surface parking at right

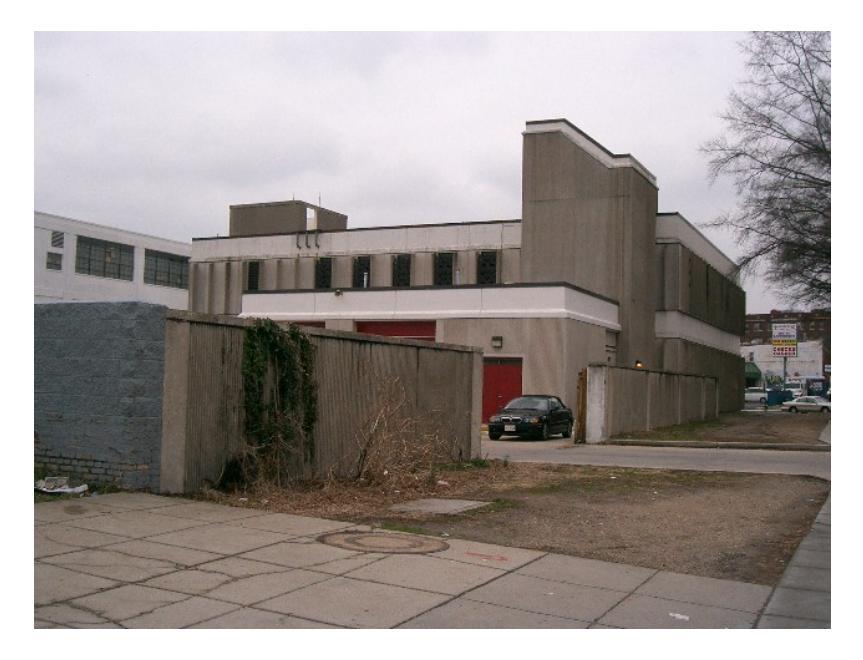
Photograph No. 3

Site viewed from rear (southeast), site's pre-cast concrete wall, and rear of building (with two-bay addition).

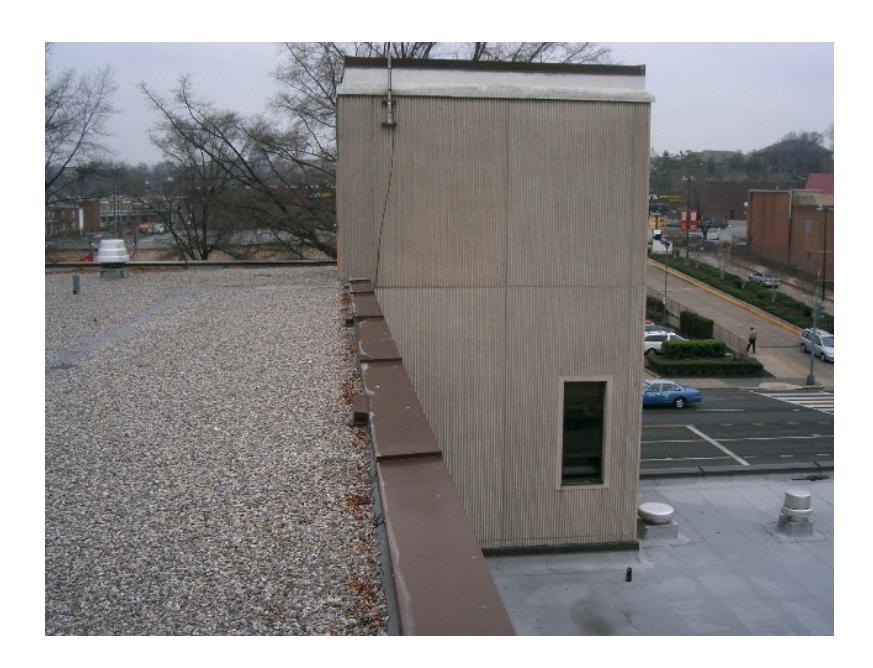
Photograph No. 4

The roof systems appear to be in good condition (see Photograph 4 in Appendix C). However, the on-site personnel reported that patching was recently required around the roof drain in the HVAC enclosure at the southeast corner of the main building roof. The second floor storage room below this roof drain had stained and damaged ceiling tile, indicating that additional patching may be required. The parapet and equipment curb flashing and the parapet's metal cap appeared to be in good condition. We recommend that additional roofing repairs be completed at the main roof's southeastern roof drain and that regular roof maintenance be provided to extend the life of the roofs.

Stone ballasted BUR upper roof and modified SBS BUR lower roof on the two bay addition and stair tower.

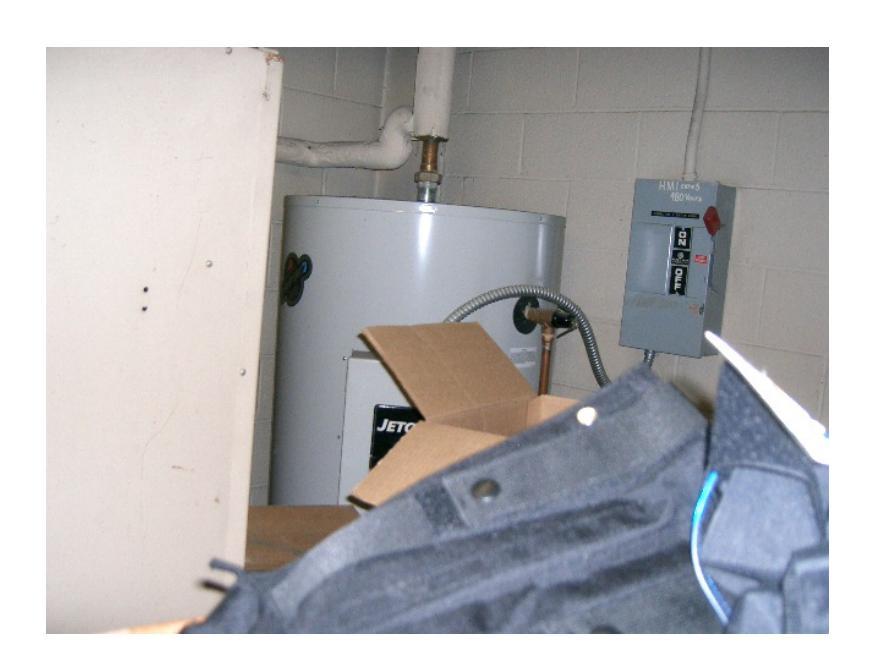
Photograph No. 19

Domestic hot water is generated by two electric water heaters (see Photograph 18 and 19 in Appendix C). Both water heaters are manufactured by Bradford White, approximately 120-gallon capacity and from five to ten years old. One water heater is in a first floor housekeeping storage room and the other is in the second floor mechanical room.

Water Heater in Second Floor Mechanical Room

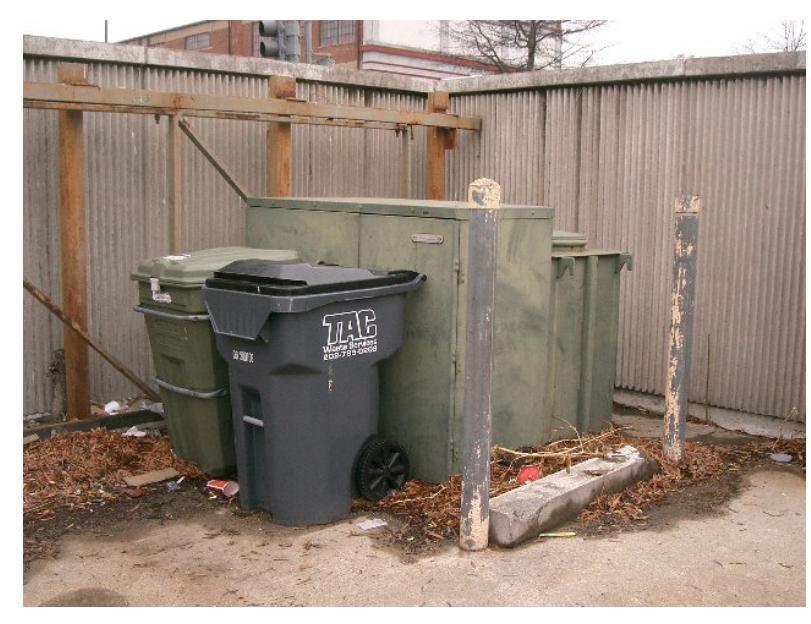
Photograph No. 21 Emergency Generator

Emergency power is supplied to a Generac automatic transfer switch (ATS) in the main electrical room, rated at 120/208-volts. A diesel-fueled generator, located outside at the northwest side of the building (see Photograph 21 in Appendix C), was manufactured by Generac (see Photograph 21 in Appendix C). The generator has a rating of 30kW / 38kVA and was manufactured in 2002. The generator is fueled from an above-ground tank located underneath the generator.

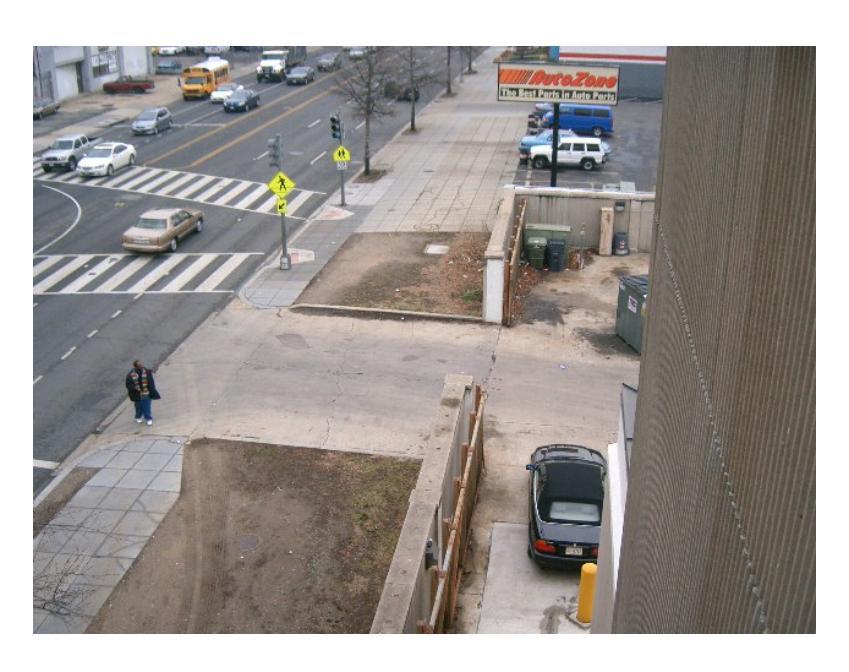
The Property faces 5th Street NE, with its rear parking area accessed from Rhode Island Avenue NE at the northwest side of the site. Fire truck access is via the concrete-paved driveway from 5th Street, directly to the three apparatus bay doors (see Photograph 31 in Appendix C). Along the northeast boundary of the site, there is a concrete-paved visitor's parking area, accessed from 5th Street NE (see Photograph 32 in Appendix C). Access from this visitor's parking area into the rear parking area is provided by swinging metal gates, typically locked.

Concrete drive from 5th Street, NE to apparatus bay doors (viewed from roof)

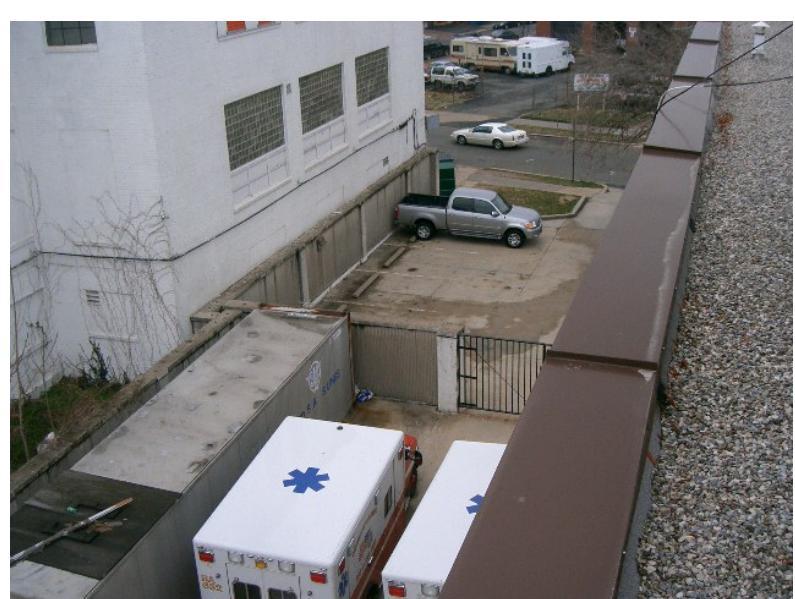
Photograph No. 32nce

Concrete paved rear parking area, with two-bay addition at left; note the pre-cast concrete perimeter wall.

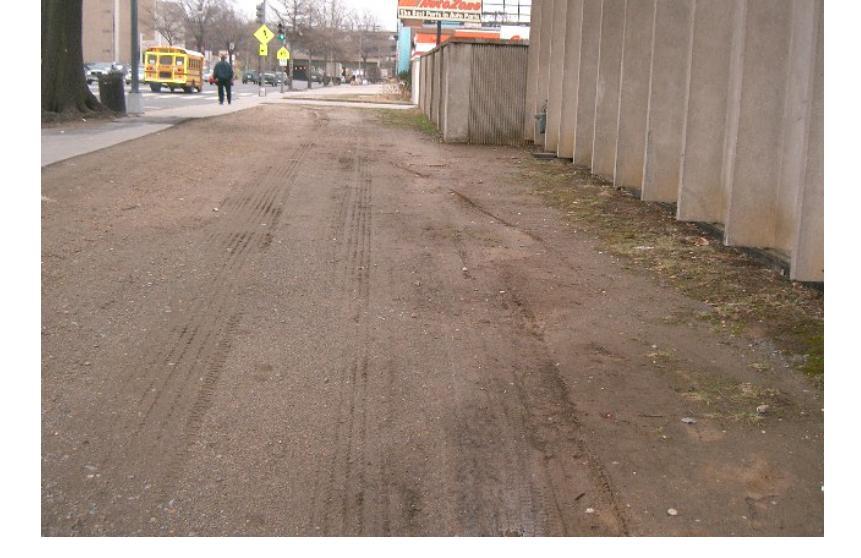
Photograph No. 35

Underground natural gas service is provided by Washington Gas to the Property. The pressure regulator and gas meter are located at northwest corner of the main building, along Rhode Island Avenue NE (see Photograph 35 in Appendix C). Gas service is routed by black steel piping to the overhead infrared heaters in the apparatus bays.

Rhode Island Avenue NE building elevation, with site's area without grass or landscaping used for visiting fire truck parking.
