Walter Reed Buildings 31 & 84 - Structural Assessment

October 22, 2019

INTRODUCTION

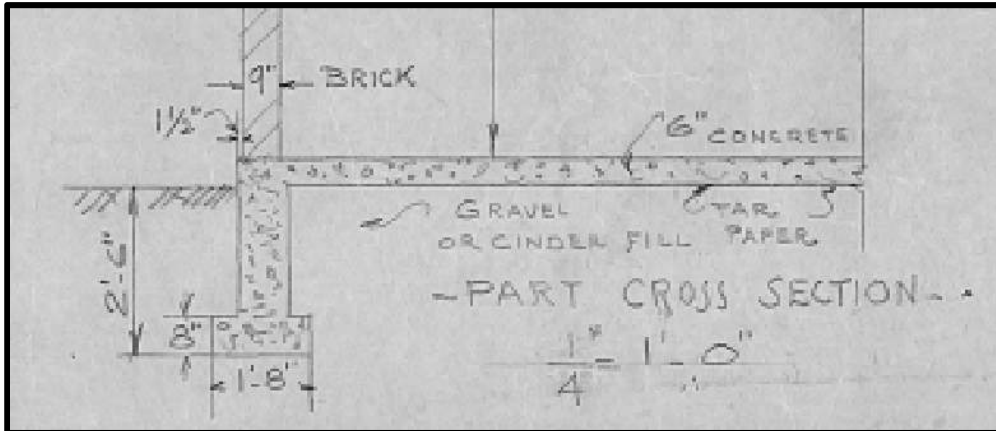
Figure 4 Building 31 Foundation Section from 1941 Drawings (2019 EHT Traceries Report)

Description: The foundations for Building 31 appear to be continuous concrete footings below the exterior masonry walls. Drawings from the 1941 addition show a 6-inch thick slab on grade and 1'-8" wide concrete footings 2'-6" below grade at the exterior walls (see Figure 4). It is likely that similar foundation construction is present at the other periods of construction. Reinforced walls were likely used where interior floors were higher than exterior grades. At the open storage shed, the foundation walls are CMU masonry. At the north elevation there is a concrete platform and steps to address the sloping grade.

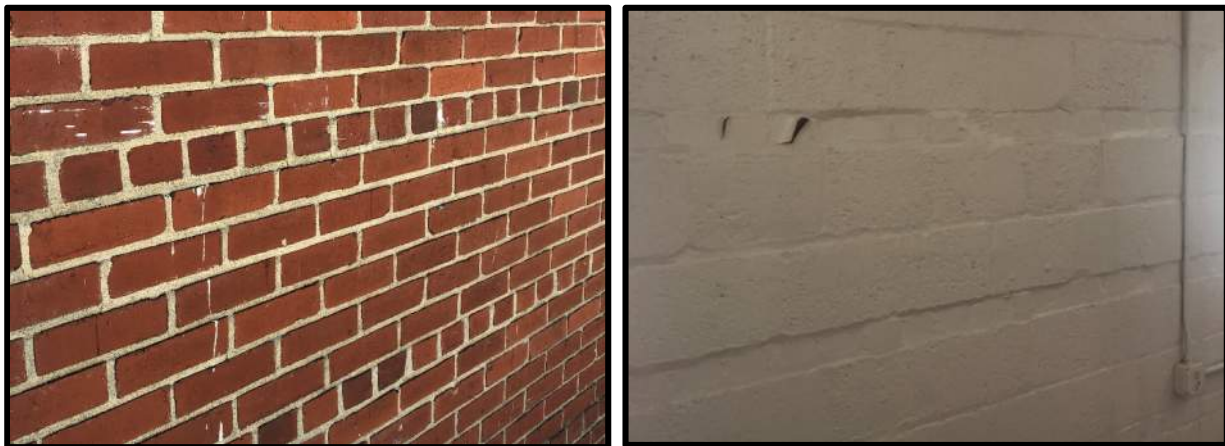
Figure 7 Wall Construction for 1941 Addition at Brick Exterior (Left) and CMU Interior (Right)

The 1941 wall construction consists of one-wythe (about 4 inches) of brick masonry at the exterior and one-wythe (about 4 inches) of CMU at the interior, with brick headers tying the two assemblies together (see Figure 7). Openings in the masonry walls appear to have steel angles serving as lintels. There is a cold joint in the masonry wall between the 1921 and 1941 construction.

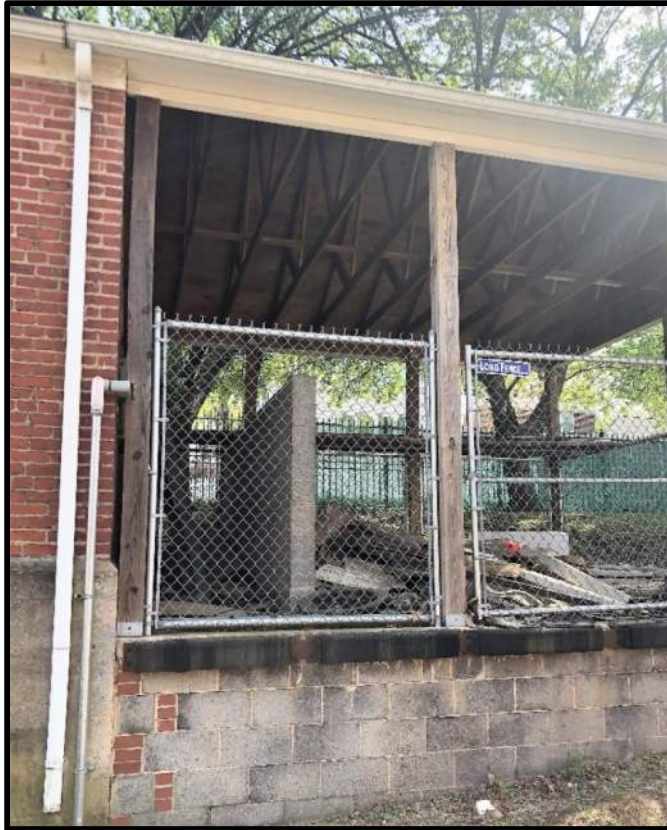
Figure 8 Wood Framing at 1971 Open Storage Shed

The 1971 shed consists of regularly spaced wood posts supporting girders that carry the load from the roof trusses (see Figure 8).

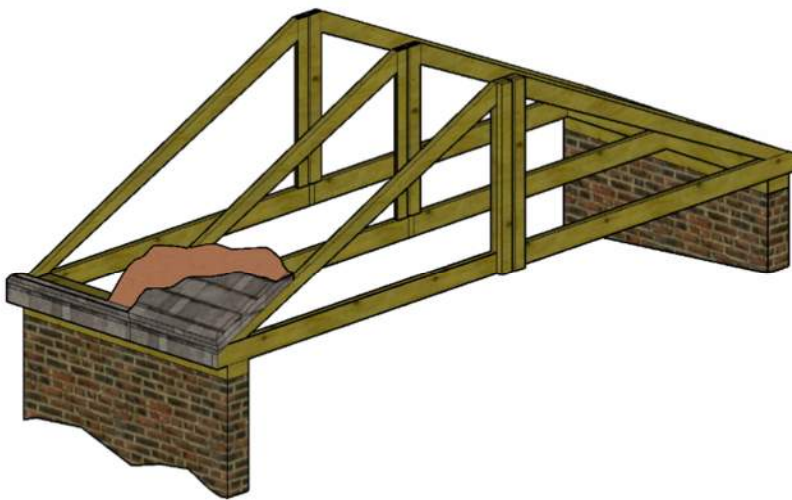
Figure 11 Typical Truss Framing at 1921 and 1941 Roofs

Description: The gable roof is framed by regularly spaced wood trusses with wood sheathing and asphalt shingles above. The framing varies slightly based on the period of construction. At the 1921 and 1941 buildings the trusses appear to be made up of 2"x6" (actual) top and bottom chords with vertical braces at the mid-span at 30 inches on-center. Trusses bear on 2" thick sill plates anchored to the top of the masonry wall (see Figure 11).

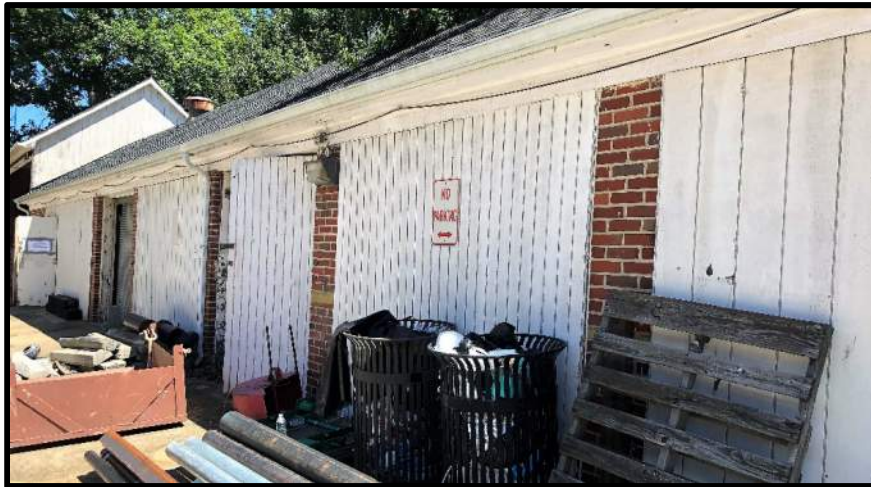
Figure 16 Brick Masonry Piers with Wood Infill at North Elevation

Description: At the original 1942 structure the north elevation consists of 2-wythe (about 9 inch) load bearing brick masonry walls/piers with wood girders spanning between openings. Many of these original openings have since been infilled with 2x8 wood stud wall construction (see Figure 16). At the south elevation it appears that most of the wall is concrete framed where it is retaining soil from the adjacent hillside. The remaining walls appear to be a mix of CMU partitions at the interior and composite CMU and brick end walls.

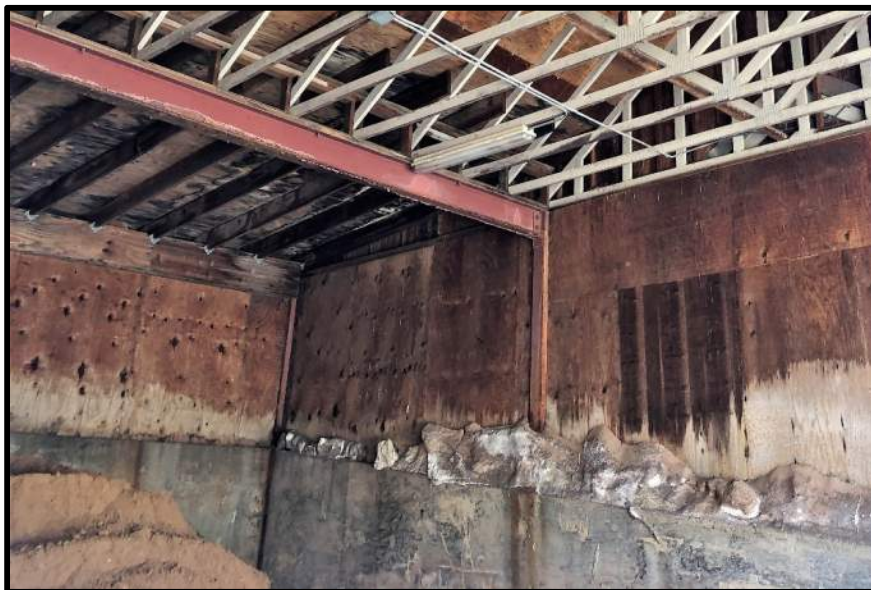
Figure 17 Steel Frame and Wood Infill at Shed Addition

At the shed, the structure consists of steel frames with tube columns (6x6) and wide flange beams (W10s). Wood stud walls with sheathing infill between steel columns, but are not load bearing (see Figure 17).

The steel framing and wood infill at the shed addition is in poor condition. Significant rusting has caused section loss of both beam and column members (see Figure 19). The wood plywood sheathing has staining especially near the base at the concrete knee walls. Based on observed conditions it is likely the underlying wood studs and sill plates have also experienced section loss.

- Concrete patching/crack repairs at foundation elements
- Foundation stabilization
- Masonry wall repointing and crack repairs
- Steel framing replacement/reinforcement and restoration of protective coating
- Wood roof framing reinforcement
- Roof and sheathing replacement

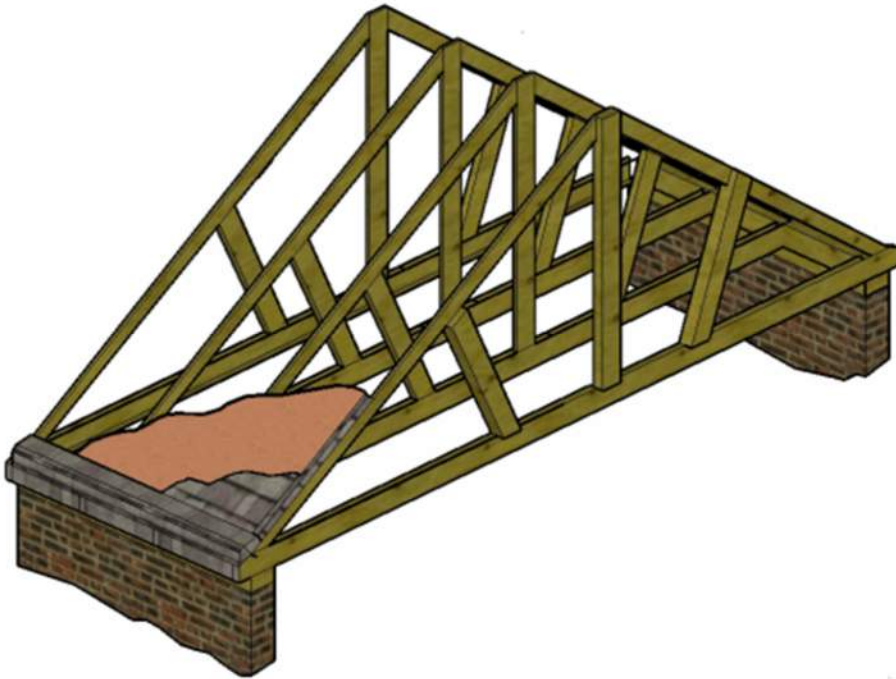
Figure 20 Roof Trusses at Original 1942 Structure

bottom chords with 1"x6" (actual) vertical and diagonal braces. Trusses bear on double 2" thick sill plates anchored to the top of the masonry wall (see Figure 20).

Assessment: At the original 1942 structure only limited observations could be made. Some signs of moisture infiltration and roof leaks were noted, but no areas of significant distress or material loss were identified. The roof framing, where exposed, is in poor to fair condition.

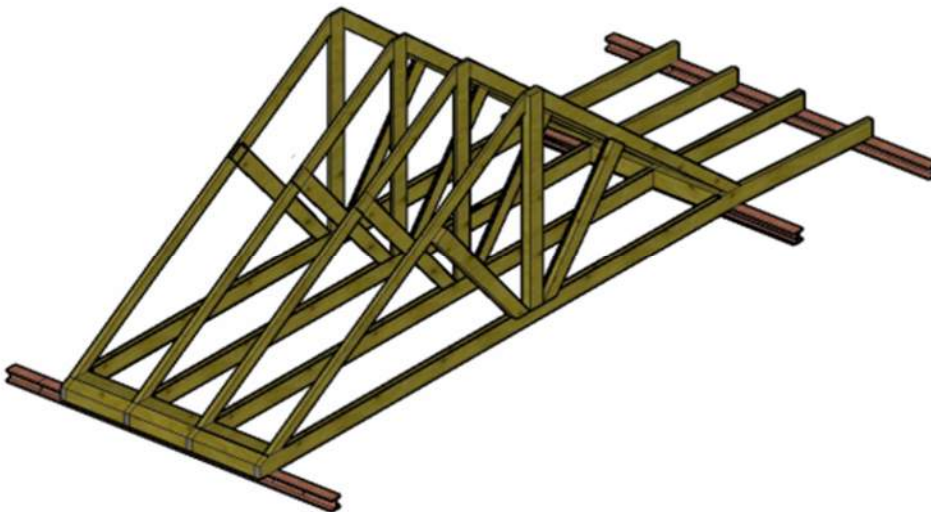
Figure 21 Roof Trusses at 1970s Shed Addition

At the shed addition the framing consists of 2x4 (nominal) trusses at about 2 feet on-center at the north end gable. The flat roof at the south end of the shed is framed by 2x8 (nominal) sloped rafters. The roof framing is supported by three lines of steel framing. The wood framing has plywood sheathing and asphalt roof shingles above (see Figure 21).

At the shed structure the plywood sheathing had significant water staining. Members could not be assessed up close, but it appears likely that at least some members have section loss. Some of the 2x4 truss members appear undersized for their span and some have failed (see Figure 22).
