Subject: Phase I Environmental Site Assessment
Vacant Parcel
1909 Martin Luther King Junior Avenue SE
Washington, DC 20020

**1909 Martin Luther King Junior Avenue SE
Washington, DC 20020**

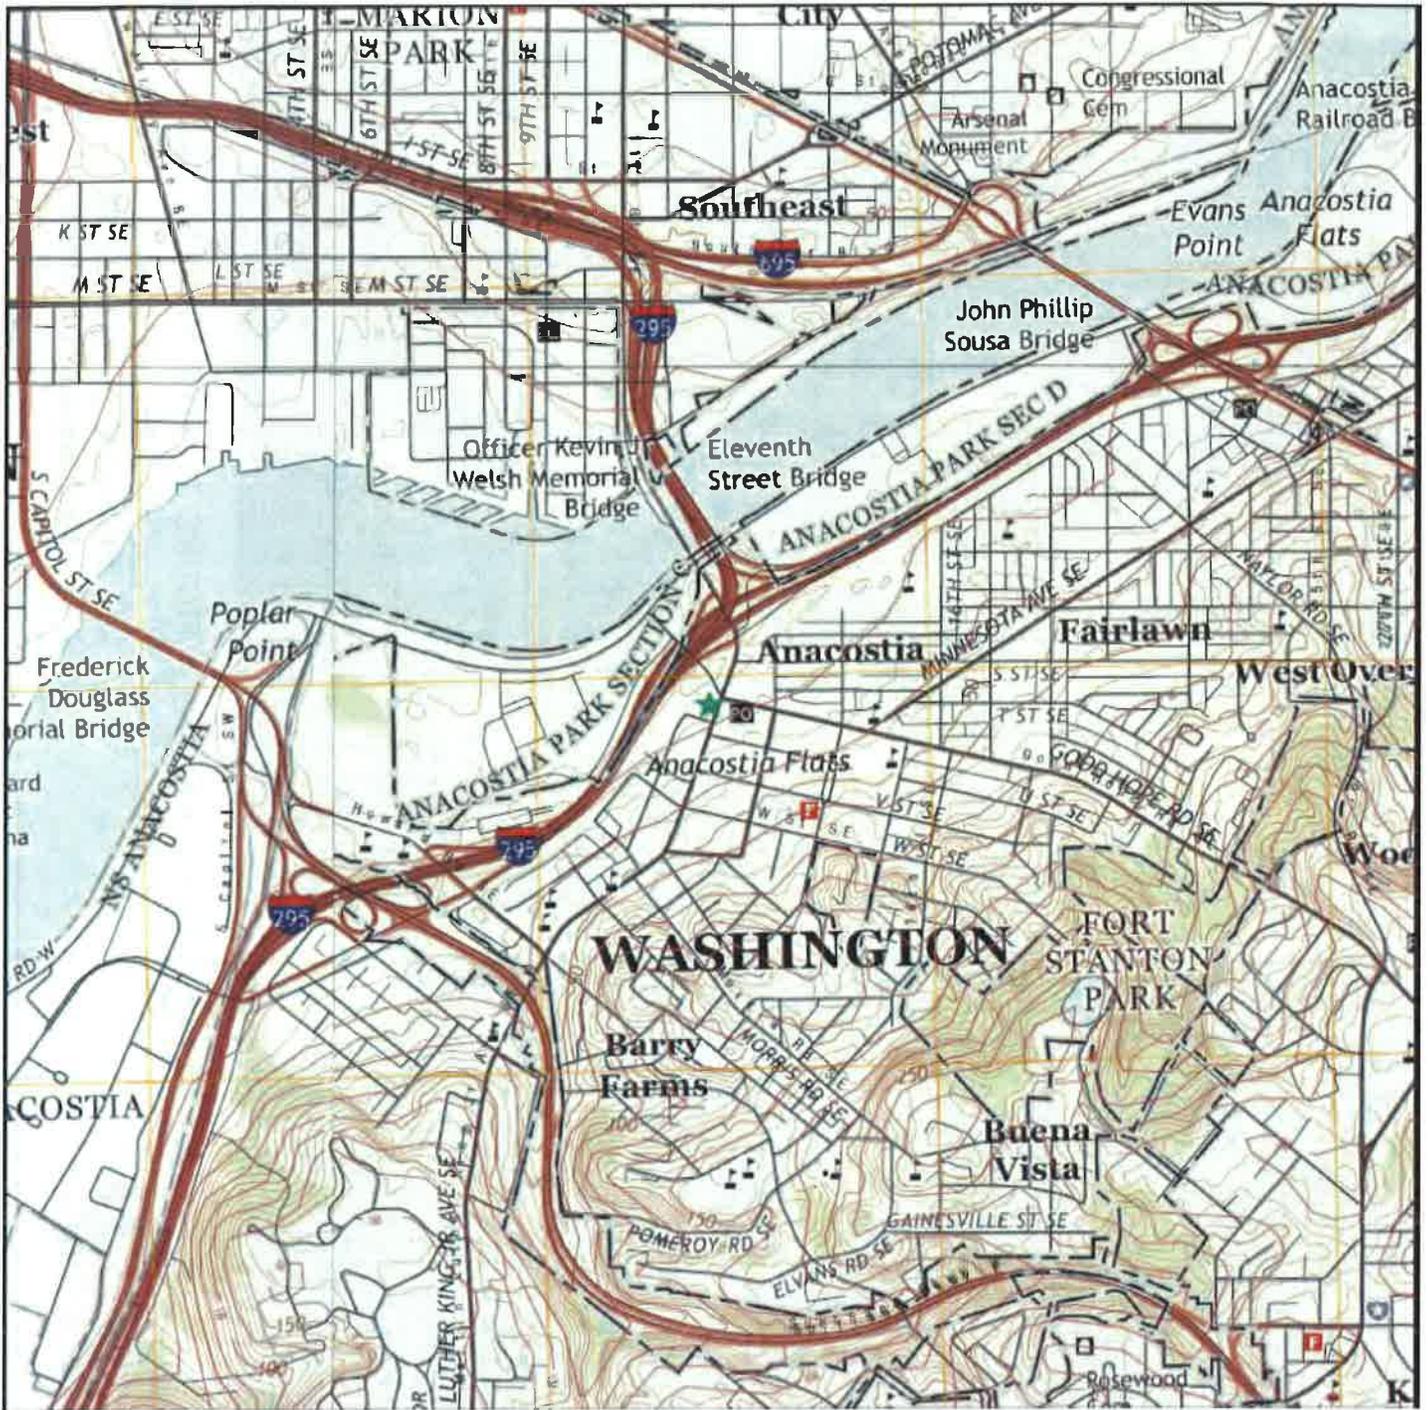
FIGURE 2: SITE VICINITY MAP

Photo Source: Google Earth
 Property Boundary Approximate

Boundaries are approximate

Based on GSI's review of the United States Geologic Survey (USGS) Anacostia, DC topographic quadrangle map, the subject property is situated at an elevation of approximately 17 feet above mean sea level. A topographic map is presented as **Figure 1**. A vicinity map of the area is provided as **Figure 2**. Photographs of the subject property are provided in **Appendix B**.

None of the adjoining properties appear likely to impact the subject property. Surrounding land use is illustrated in **Figure 2**.
