Facility Condition Assessment

Chevy Chase Community Center
5601 CONNECTICUT AVENUE NW
WASHINGTON, DC 20015
Date of Report: April 17, 2021

Submitted By:
Spectrum Management, LLC

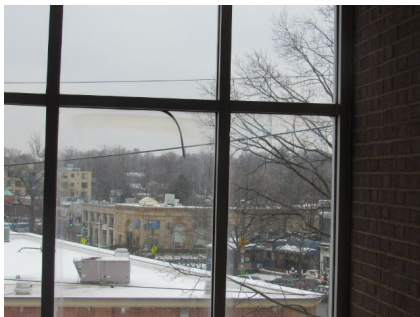
Detached Window Gasket

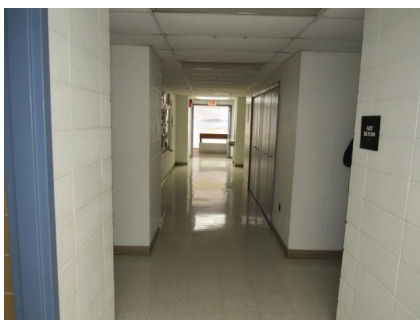
CMU Block Partitions - Plain

Walls were in good condition. Replacement is life-cycle driven.

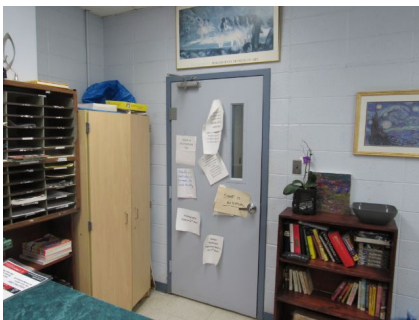
Swinging Doors - Commercial - Hollow Metal

Doors are in good condition. Replacement is life-cycle driven.

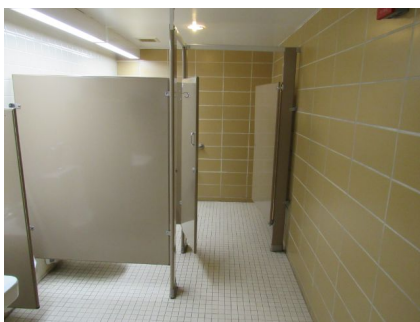
Toilet Partitions - Painted Steel

Partitions were in fair to good condition. Budget for restroom refurbishment within the next five to ten years.

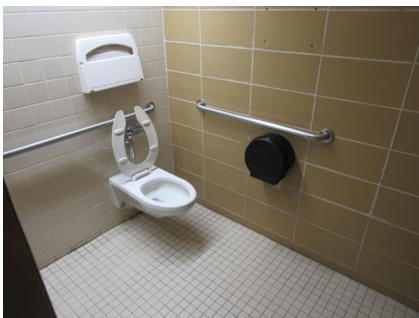
Ceramic Wall Tile (Restrooms)

Tiles are in fair to good condition. Replacement should be included as part of a larger restroom refurbishment project towards the end of the 10 year study period.

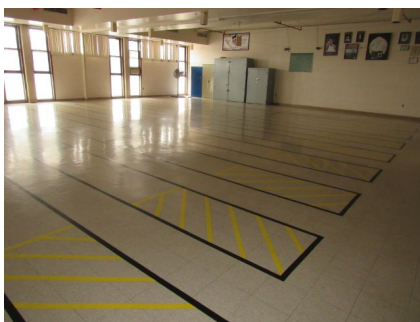
VCT (12" x 12")

The vinyl tiles were in fair condition with numerous areas of cracking and staining noted. Tiles should be replaced within the next three years.

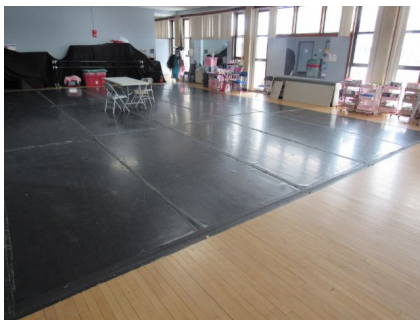
Wood Flooring - Pre-School Play Room

Flooring is in fair condition with areas of warping noted. Budget for replacement within the next three years.

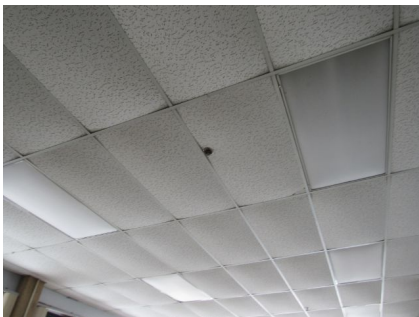
ACT System - Standard

The ceiling was in fair to poor condition with areas curled corners and areas of damage noted. Replacement of the ceiling system should be anticipated within the next three to five years.

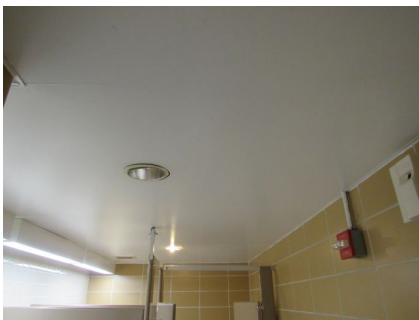
GWB Ceiling System - Painted

Ceilings were in good condition.

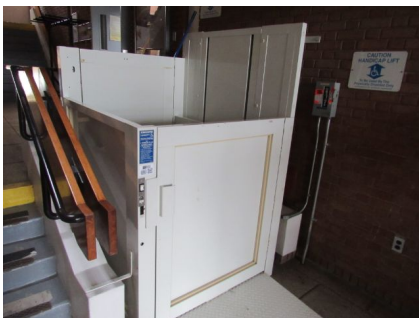
Wheelchair Lift - 750lb (# 1)

The lift was in good condition. Replacement is life-cycle driven.

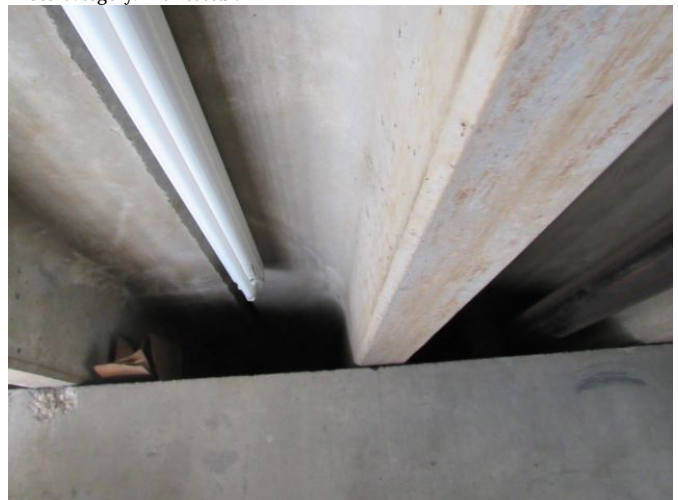
Concrete Superstructure
Concrete Superstructure
March 27, 2021

The structural system appeared to be in good condition.

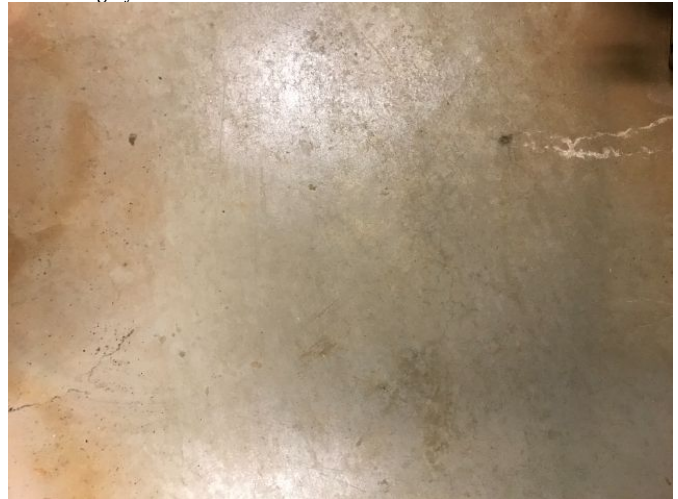
Structural Slab on Grade - Non-Industrial
Structural Slab on Grade - Non-Industrial
March 27, 2021

The floor slab appeared to be in good condition.

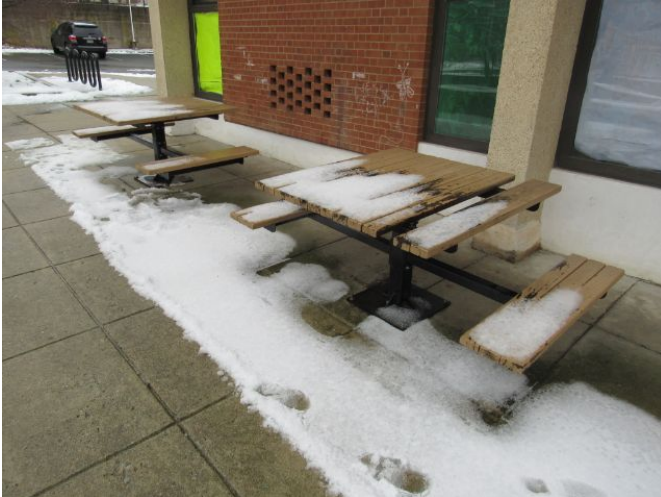
3' Square Wood Tables with 4 Seats
3' Square Wood Tables with 4 Seats
March 27, 2021

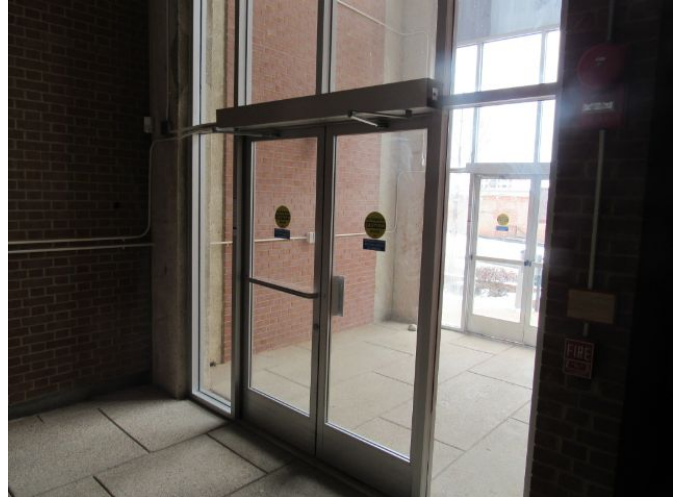
Double Swinging Doors - Commercial - Glazed
Double Swinging Doors - Commercial - Glazed
March 27, 2021

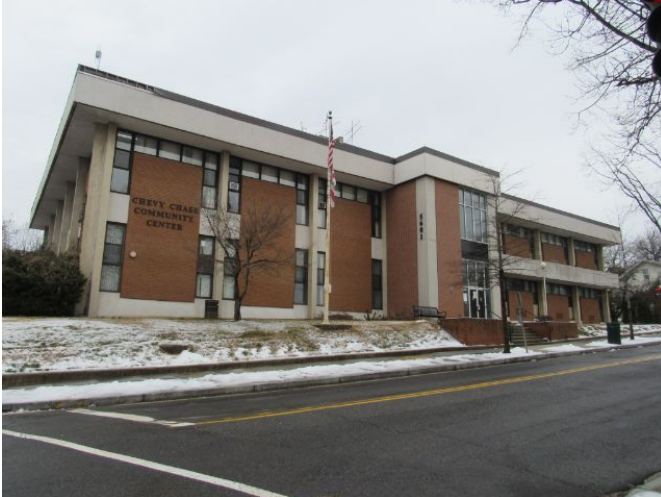
Chevy Chase Community Center
Exterior Overview
March 27, 2021

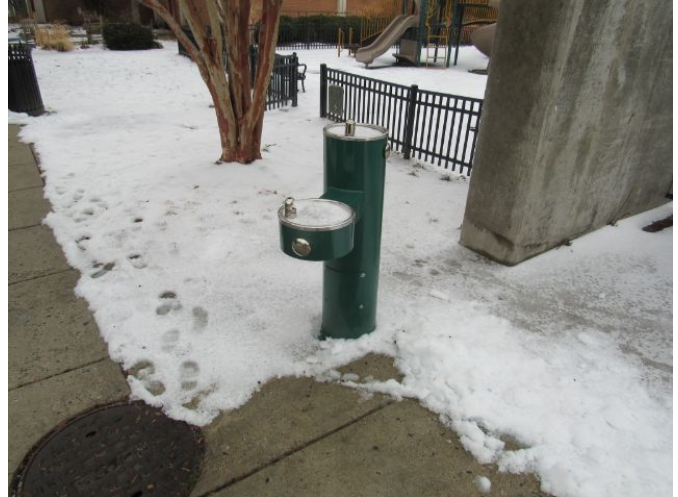
Water Cooler - Exterior Grade
Water Cooler - Exterior Grade
March 27, 2021

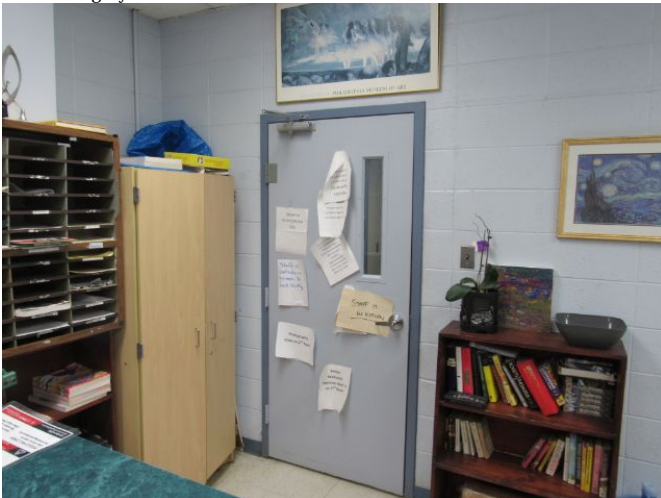
Swinging Doors - Commercial - Hollow Metal
Swinging Doors - Commercial - Hollow Metal
March 27, 2021

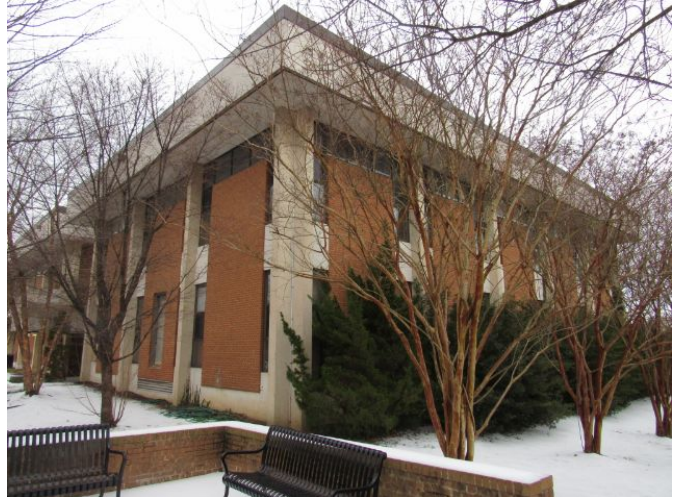
Exterior Architectural Elements - Precast Concrete
Exterior Architectural Elements - Precast Concrete
March 27, 2021

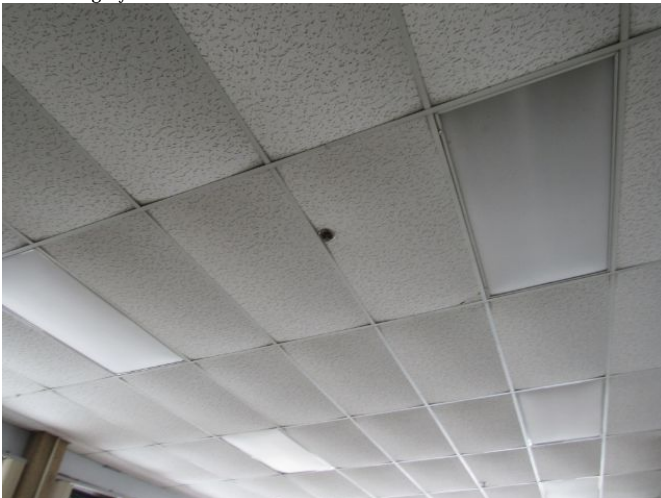
ACT System - Standard
ACT System - Standard
March 27, 2021

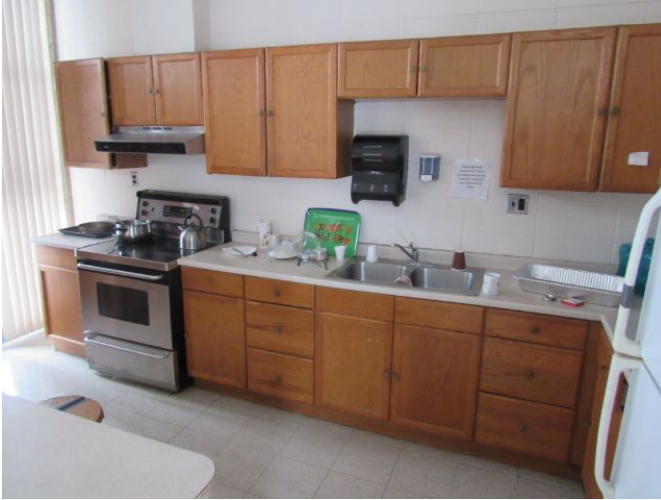
Kitchen Cabinets - Stock - Laminate Countertop
Kitchen Cabinets - Stock - Laminate Countertop
March 27, 2021
